# Your Inspection Report

2051 Phantom Rider Trl  
Spring Branch, TX 78070

**INSPECTION DATE:**  
Monday, February 23, 2026

**PREPARED BY:**  
Casey Herbert, 24484

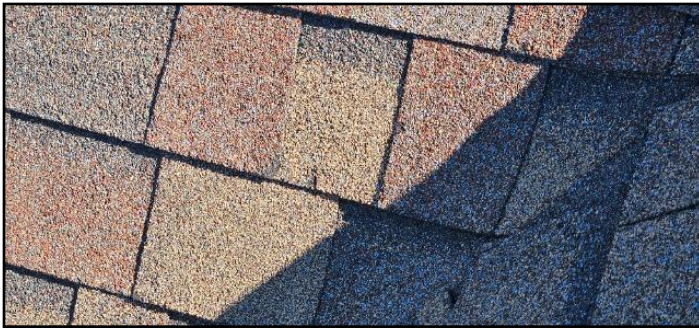
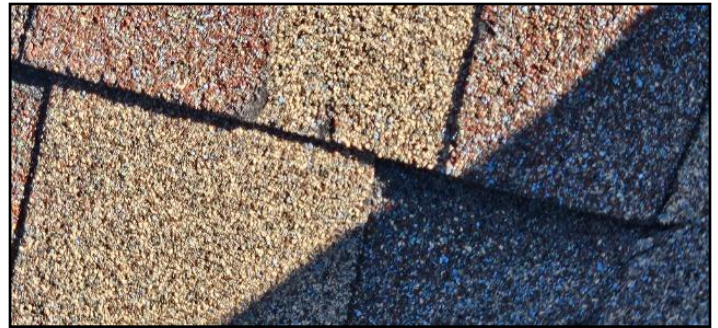
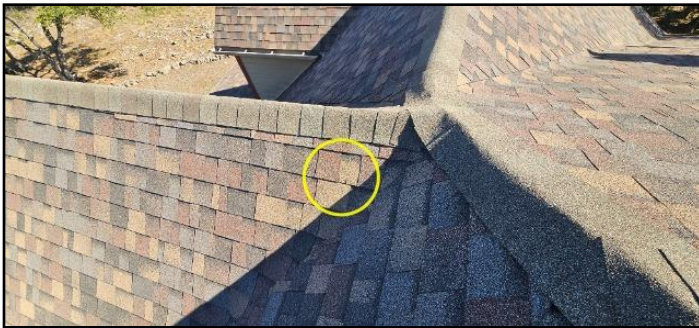
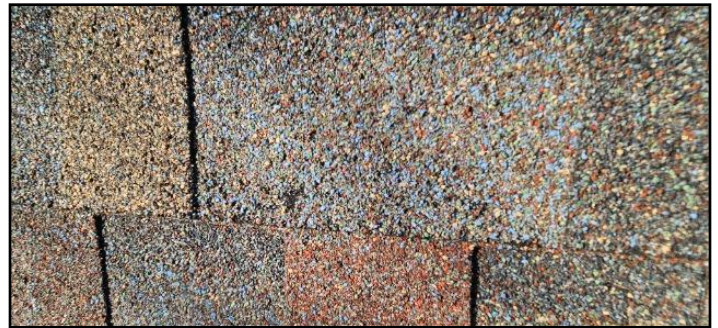
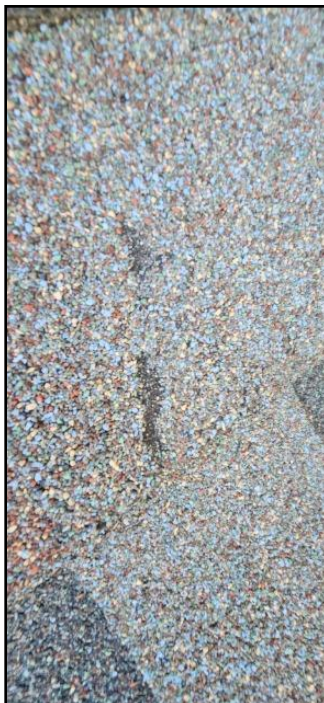
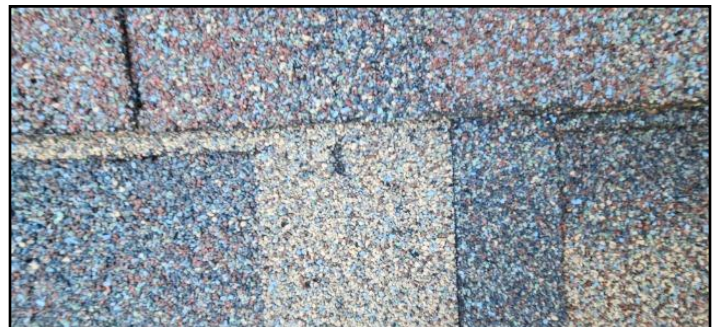
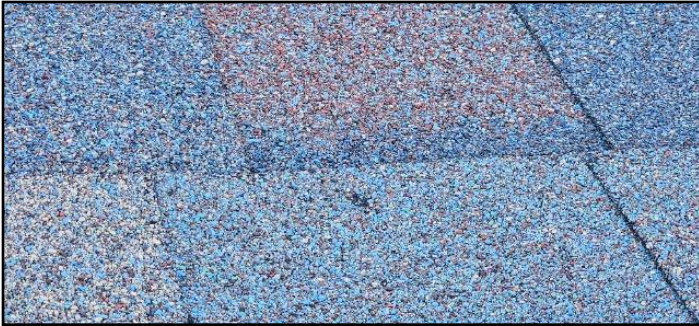
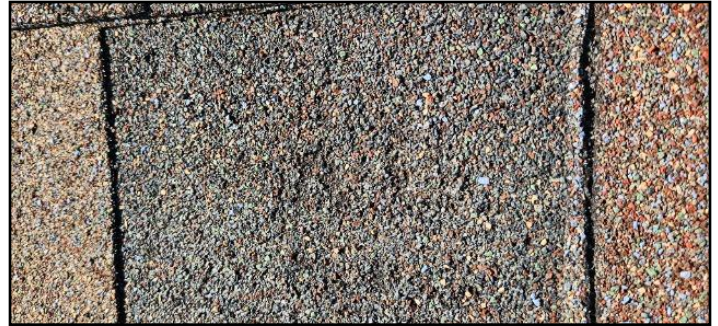
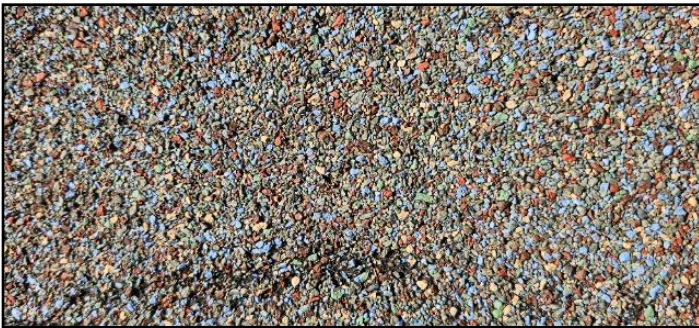
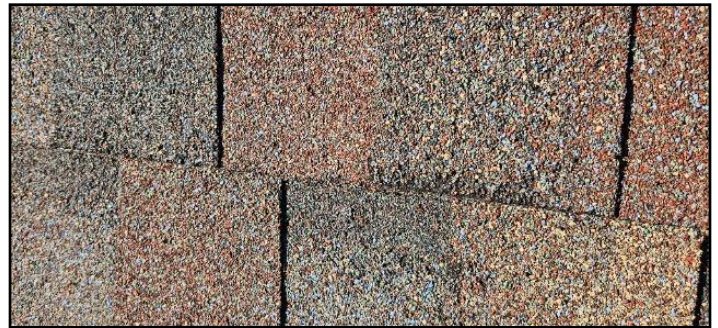
Multiple damaged shingles at the time of the inspection.

**Implication(s):** Chance of water damage to structure, finishes and contents

**Task:** Repair by a qualified roofing contractor

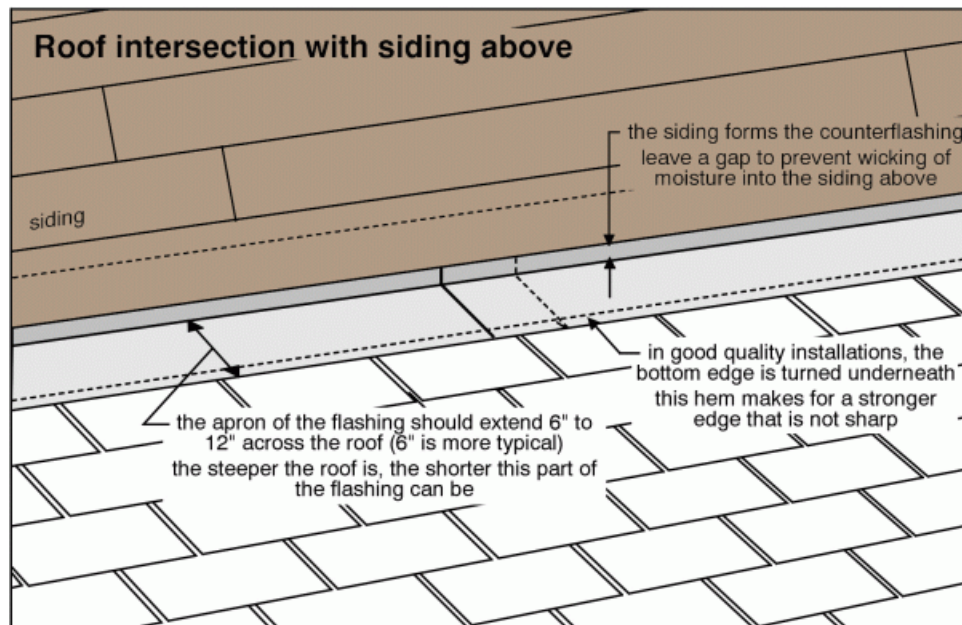
### 2. Condition: • [Siding not cut back](#)

Siding should be cut at the roof to wall intersection to prevent wicking, rot and deterioration of the siding.

**Implication(s):** Chance of water damage to structure, finishes and contents

**Task:** Repair

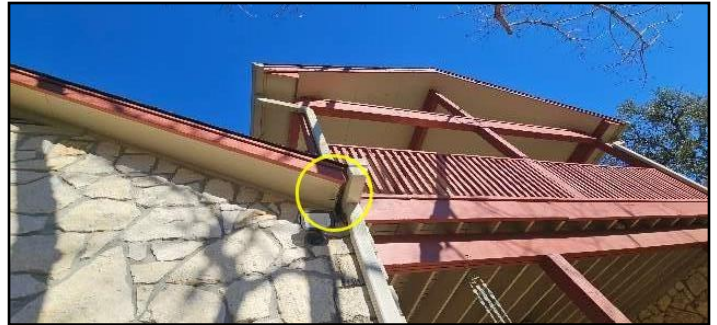
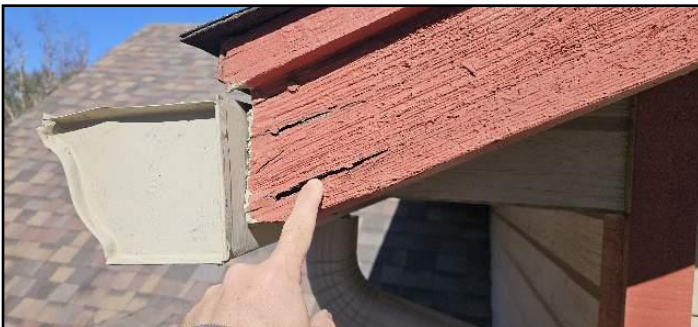
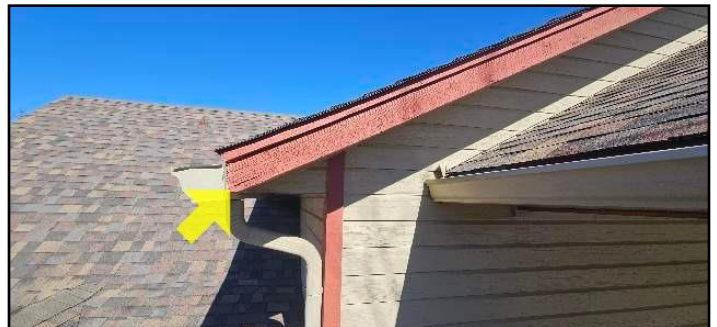
#### 4. Condition: • [Rot](#)

Multiple areas of wood rot at the soffit/eaves

Task: Repair

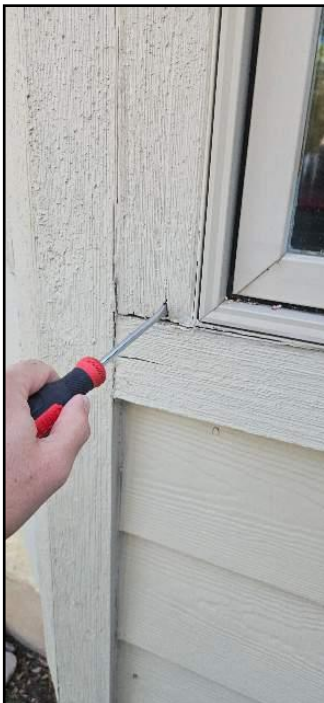
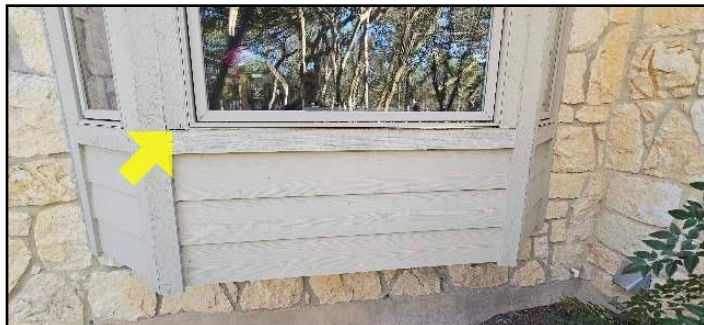
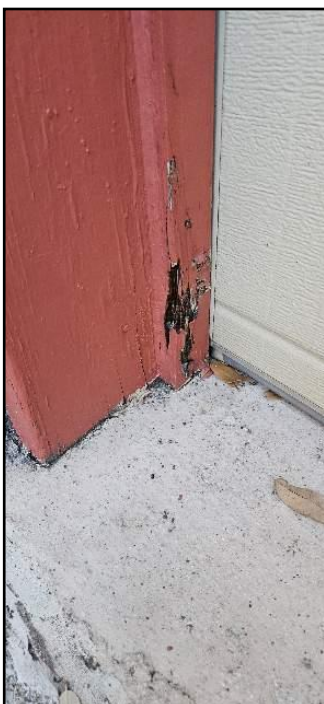
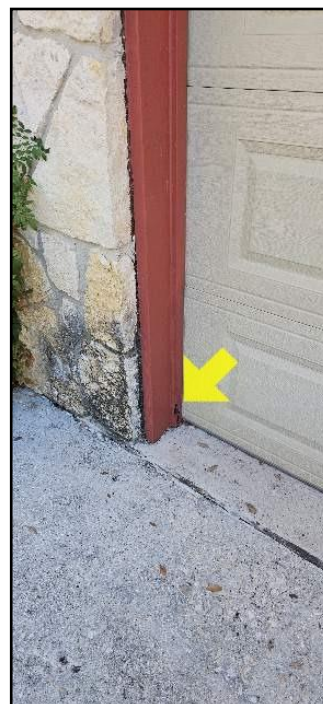
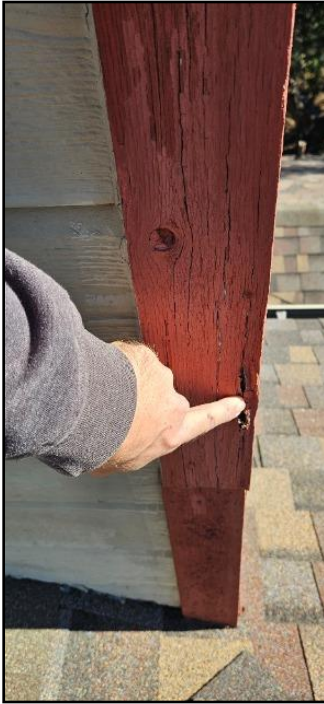
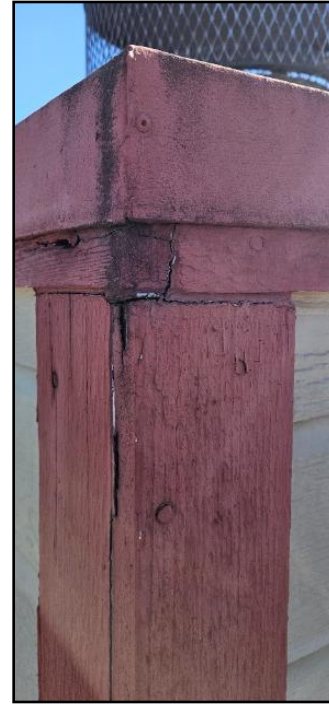
Areas of wood rot at the exterior trim.

**Implication(s):** Chance of water damage to structure, finishes and contents | Material deterioration

**Task:** Repair

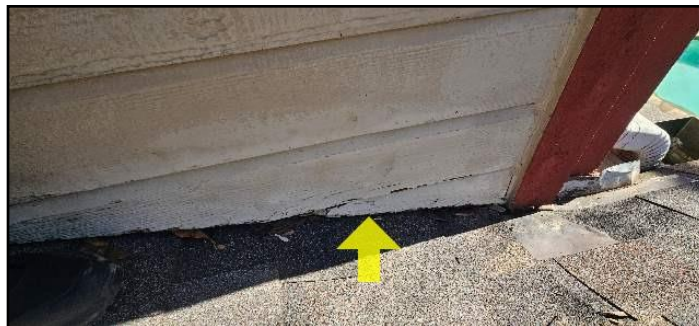
One area of rot at the wood siding

**Implication(s):** Weakened structure | Material deterioration

**Task:** Repair

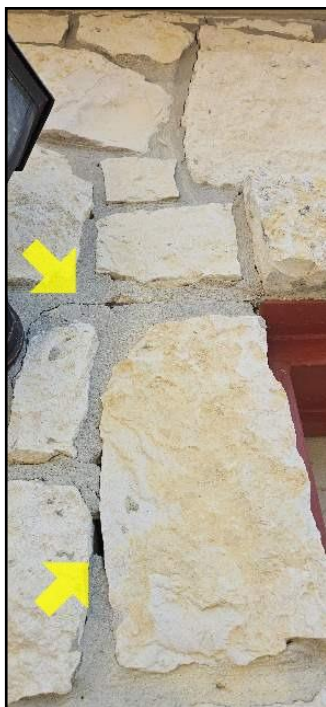
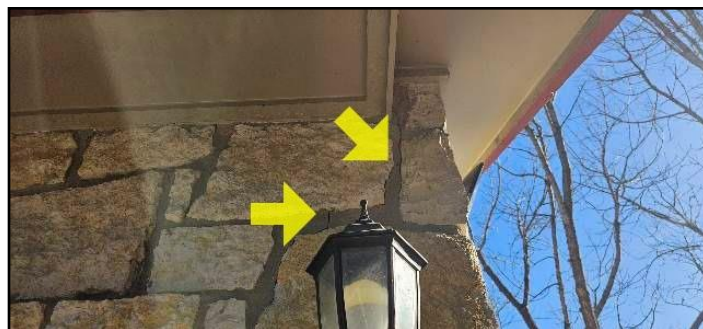
Areas of mortar deterioration at the exterior masonry.

**Task:** Repair

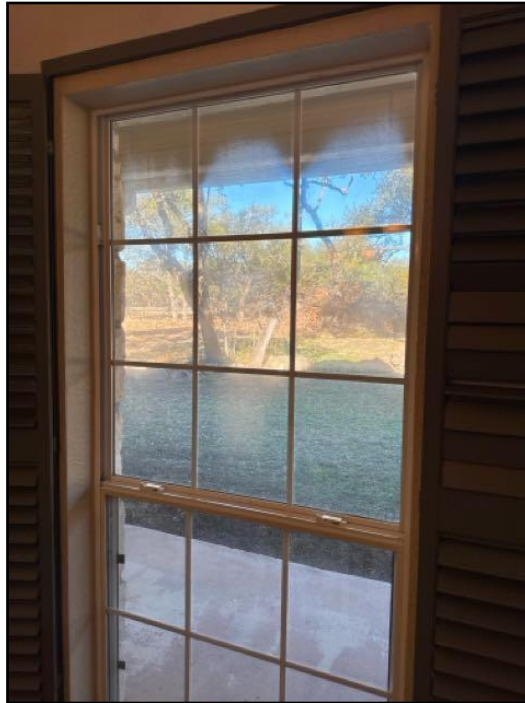
36. Lost seal on double or triple glazing

**Task:** Repair

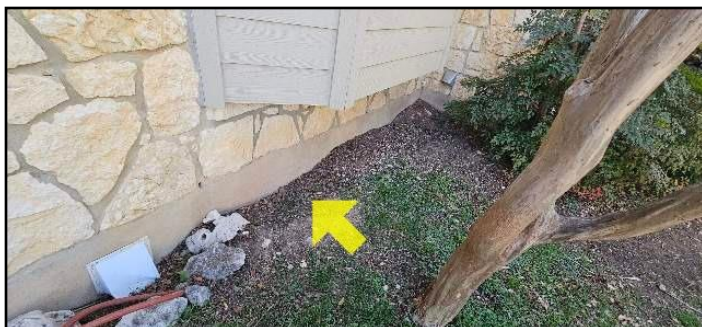
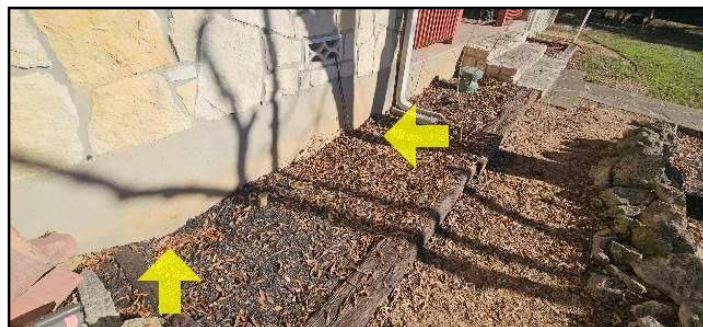
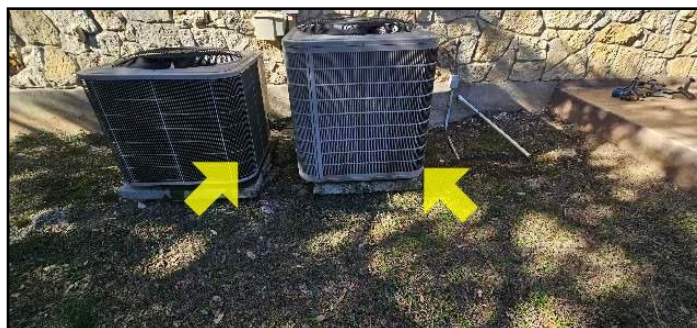
Improper grading at multiple areas around the house causing water ponding next to the foundation. The inspector recommends repair to prevent structural damage.

**Implication(s):** Chance of water damage to structure, finishes and contents

**Task:** Repair

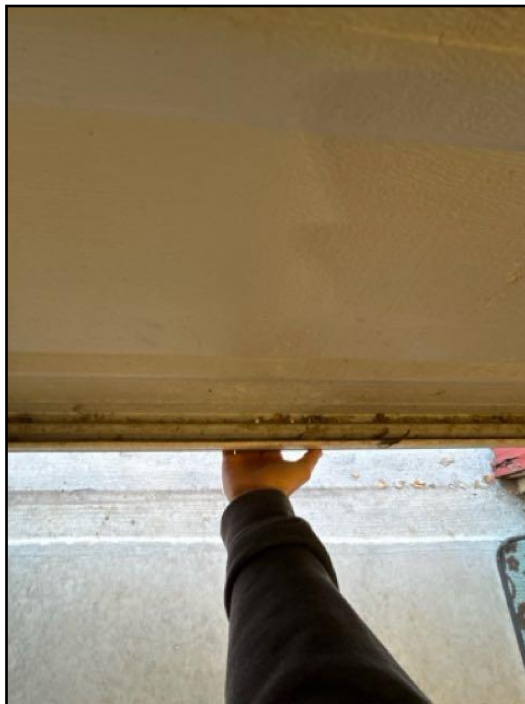
The garage door opener failed to auto reverse when tested.

41. Fails to auto reverse

**Task:** Repair

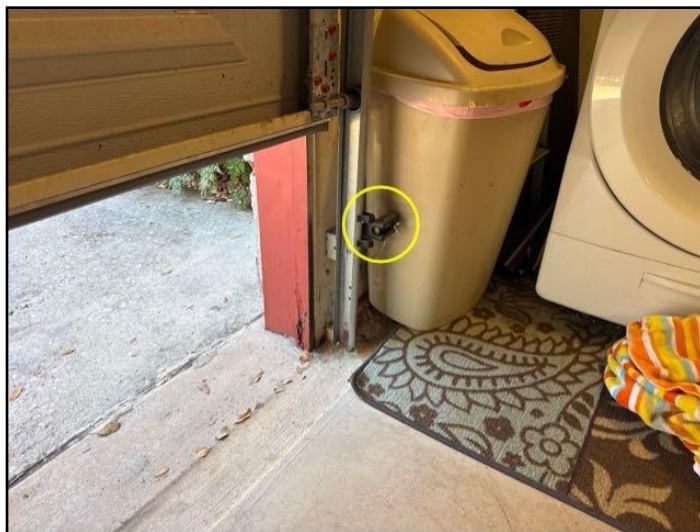
**12. Condition:** • Photoelectric sensor more than 6 inches above the floor

The photoelectric sensors should be installed within 6" of the ground, recommend correction for safety.

**Task:** Repair

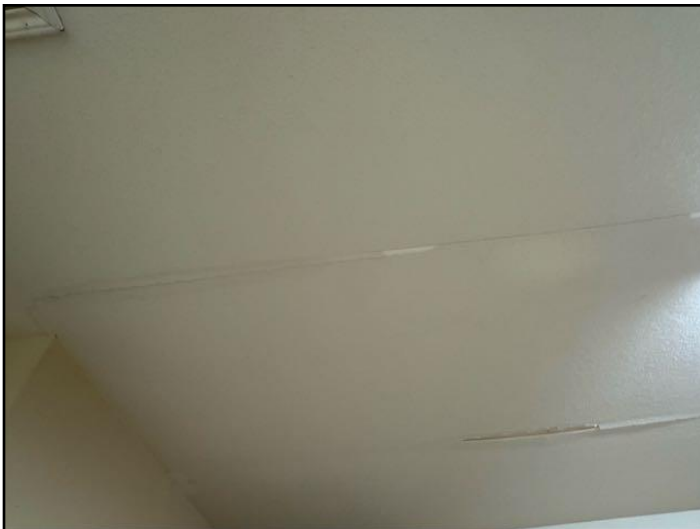
The foundation is settled and has elevation changes that appear to be within tolerance. Interior cracking ceiling and walls is an indication of structural settlement. The inspector recommends repair to the exterior grading and drainage to prevent structural damage.

**Task:** Repair

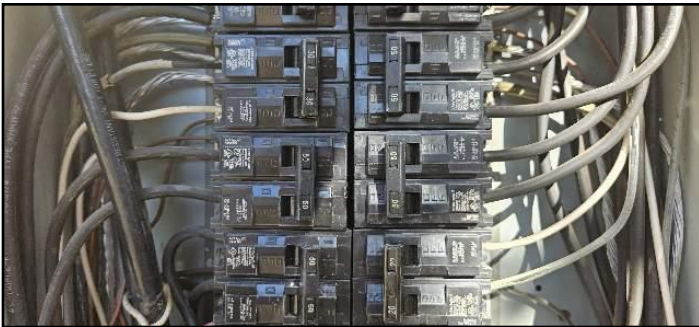
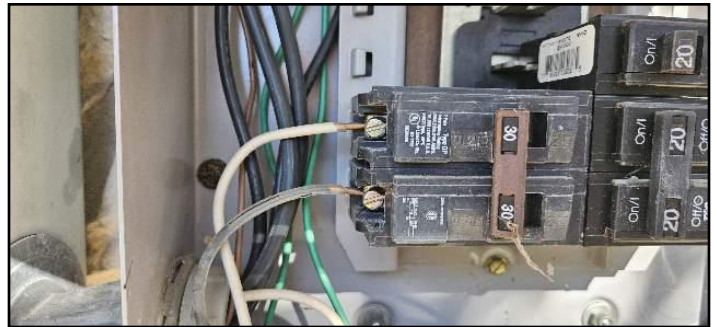
69. White wires connected to breakers not id

**Task:** Repair by a qualified electrical contractor

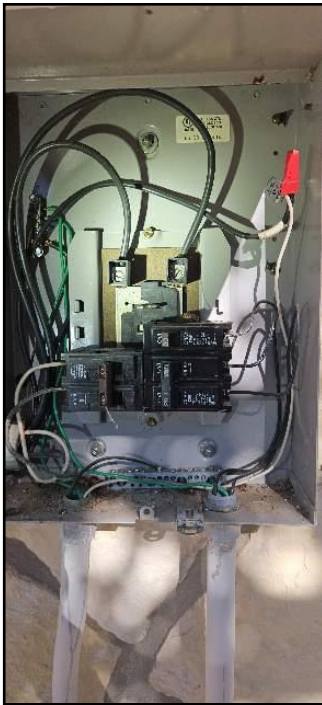
**20. Condition:** • The auxiliary panel neutral wire decreases in size and is not landed on a neutral bus bar inside the panel. Recommend repair by a qualified electrical contractor

**71.** Non standard installation of the neutral wire

**Task:** Repair by a qualified electrical contractor

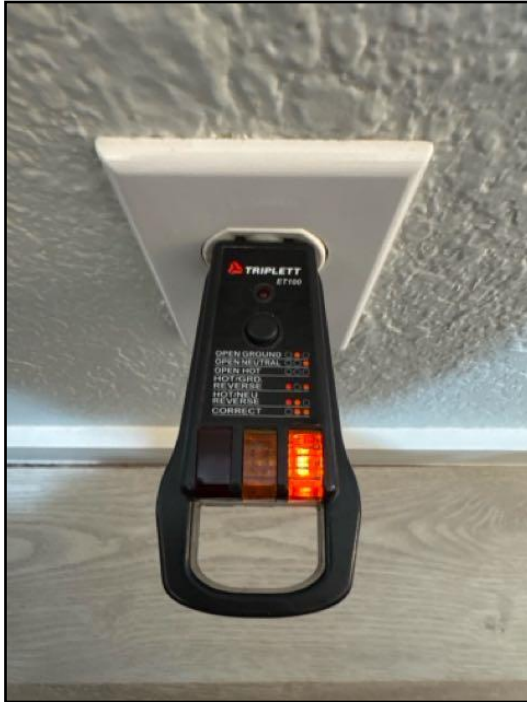
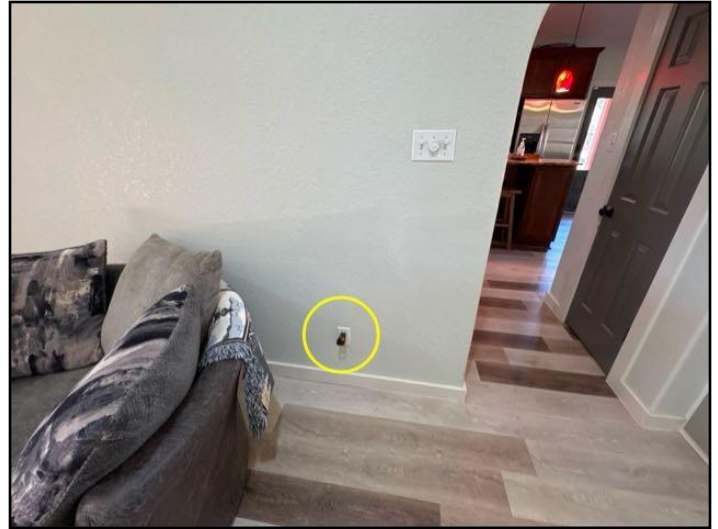
73. Open neutral

**Task:** Repair by a qualified electrical contractor

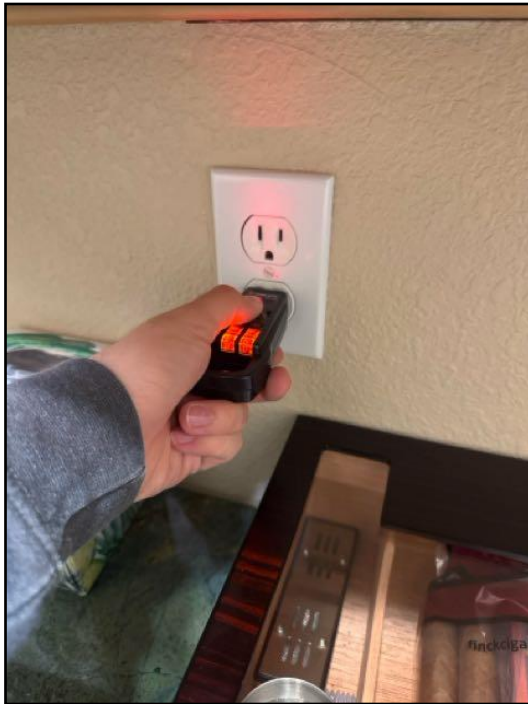
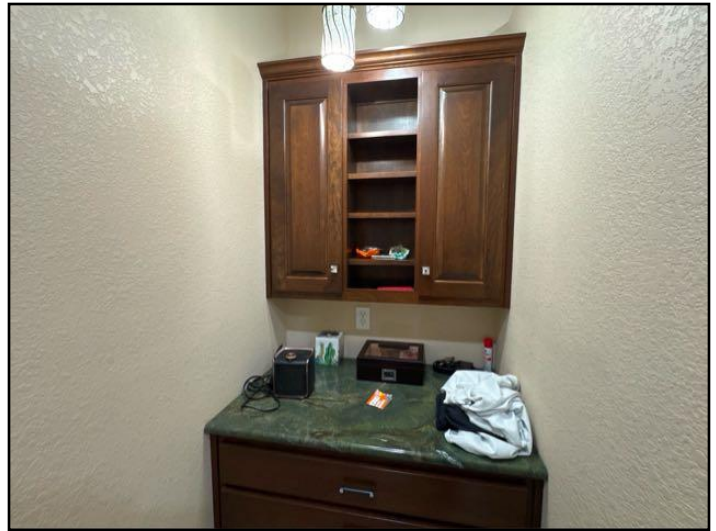
75. Bathroom GFCI missing

**Task:** Repair

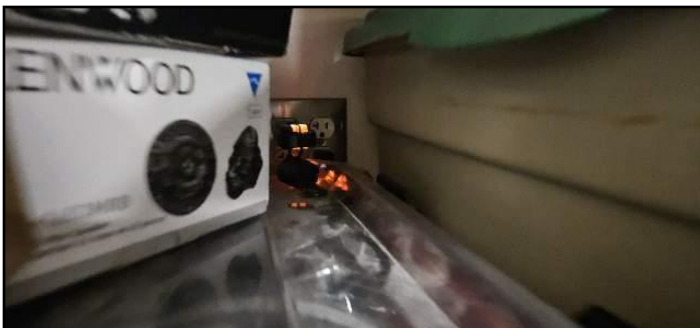
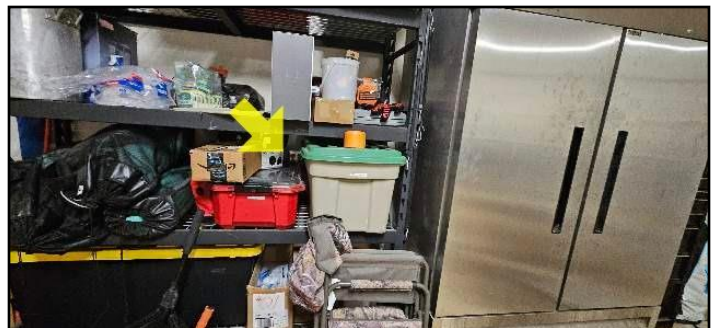
77. Garage GFCI missing

**Task:** Repair by a qualified electrical contractor

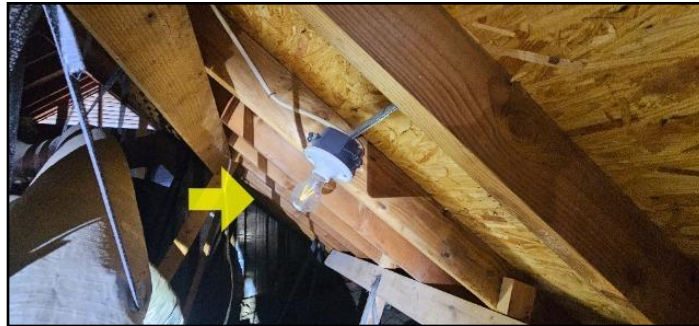
79. Exposed to mechanical damage (No cage or...

**Task:** Repair

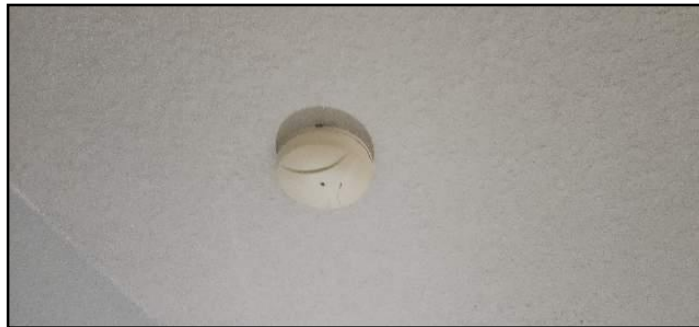
• Distribution system\Smoke alarms (detectors): More than 10 years old Notes: Smoke detectors are designed to turn yellow after 10 years indicating that they should be replaced.

80. More than 10 years old

**Task:** Replace

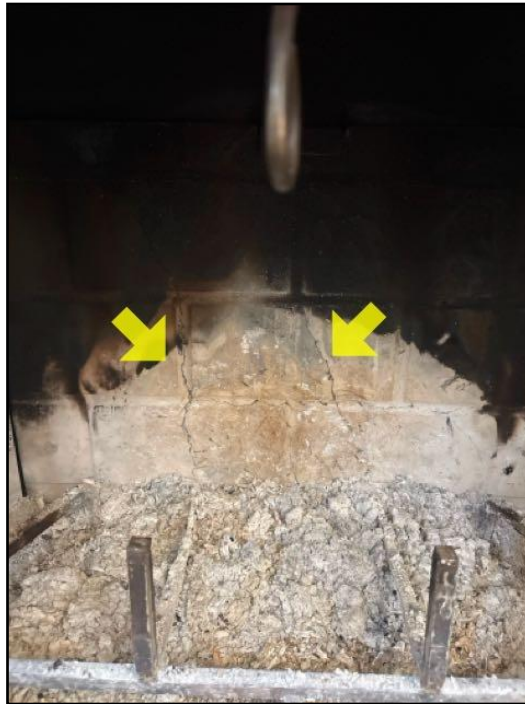
• Fireplace\Firebox: **Cracked masonry or refractory** Notes: **Cracking at the fireplace**

90. Cracked masonry or refractory

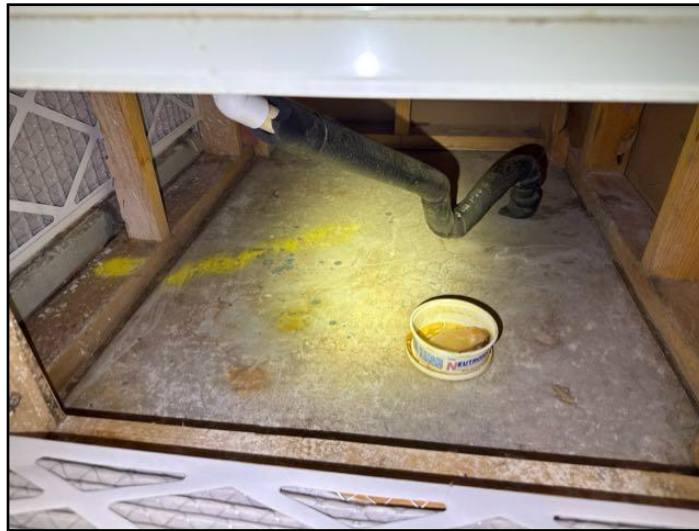
**• Air conditioning\Condensate system: No drain/safety pan installed at the HVAC equipment.**

96. No drain/safety pan installed at the HVAC...

**Task:** Repair by a qualified HVAC contractor

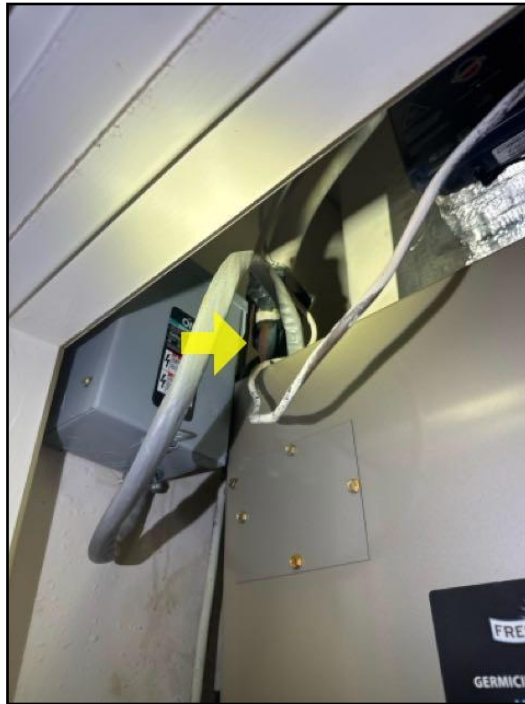
**Notes: Deteriorated insulation at the HVAC refrigerant line at the first floor air handler**

97. HVAC refrigerant Insulation deteriorated,...

**Maintenance item, recommend replacement.**

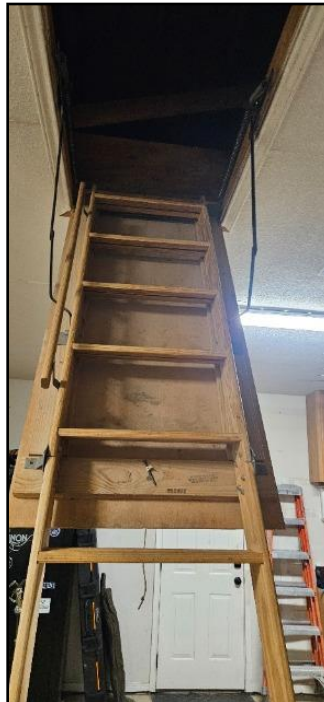
98. Plywood not fire rated

**Task:** Repair

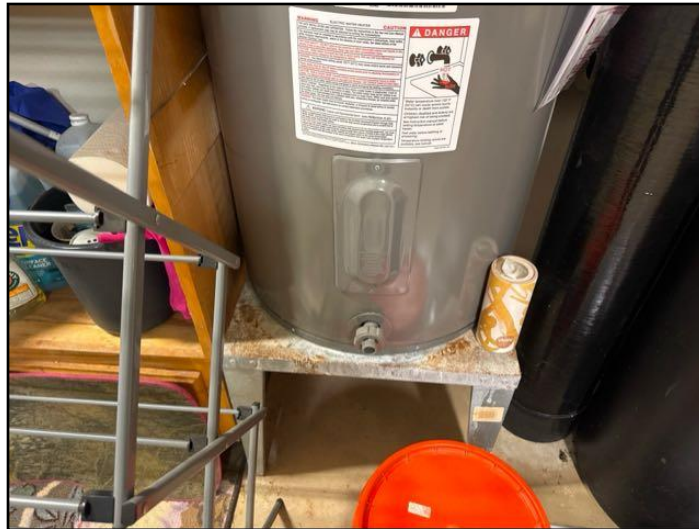
• *Water heater\Tank:* **Safety pan and drain missing** *Notes:* **No safety pan/drain installed on the water heater. All water heaters should have a safety pan with a drain that terminates to the exterior of the home.**

**102.** Safety pan and drain missing

**Task:** Repair

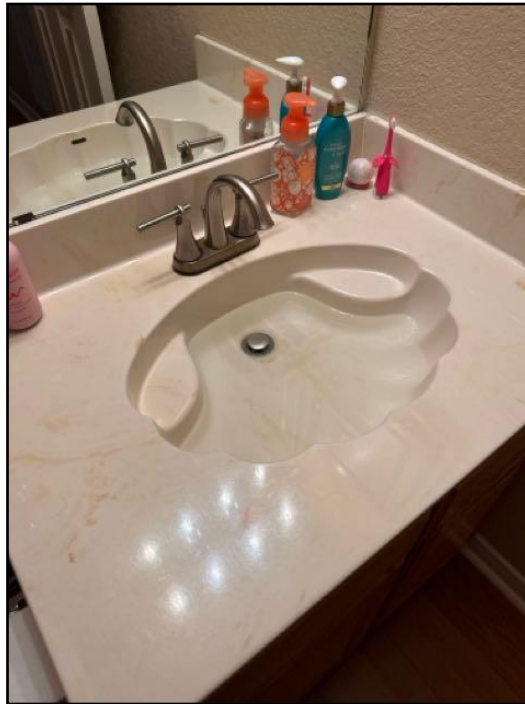
107. *Slow drains*

**Task:** Repair

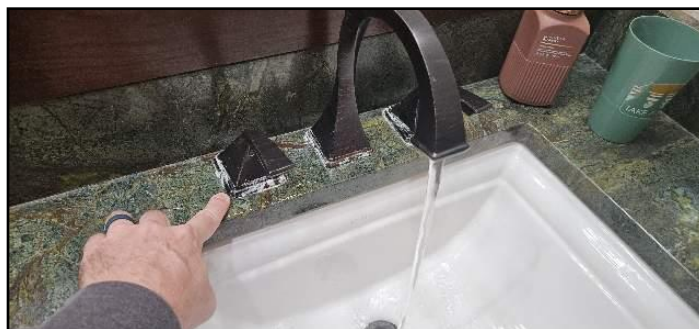
**• Fixtures and faucets\Faucet: Drip, leak Notes: Leak at the faucet handle at the master bathroom**

### 39. Condition: • [Drip, leak](#)

108. Drip, leak

**Task:** Repair

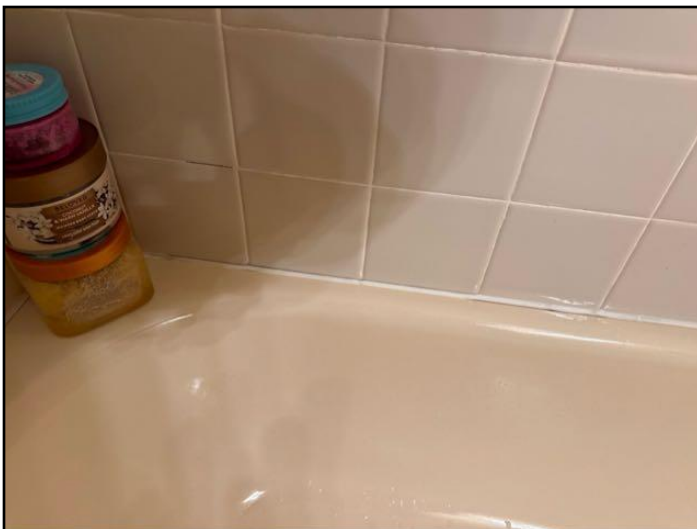
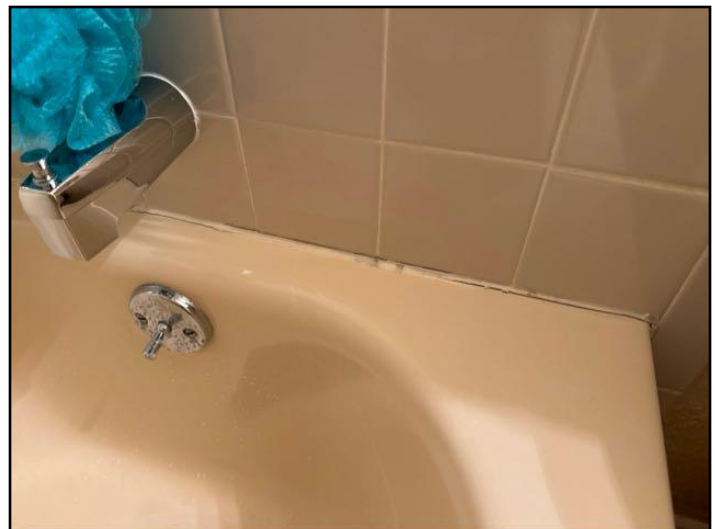
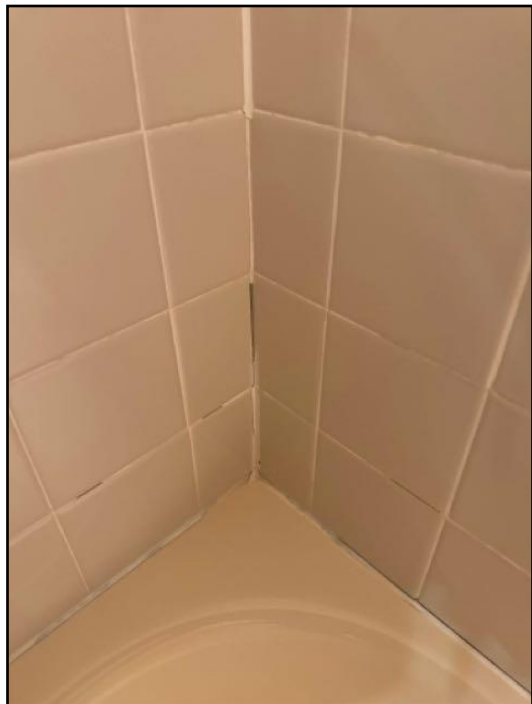
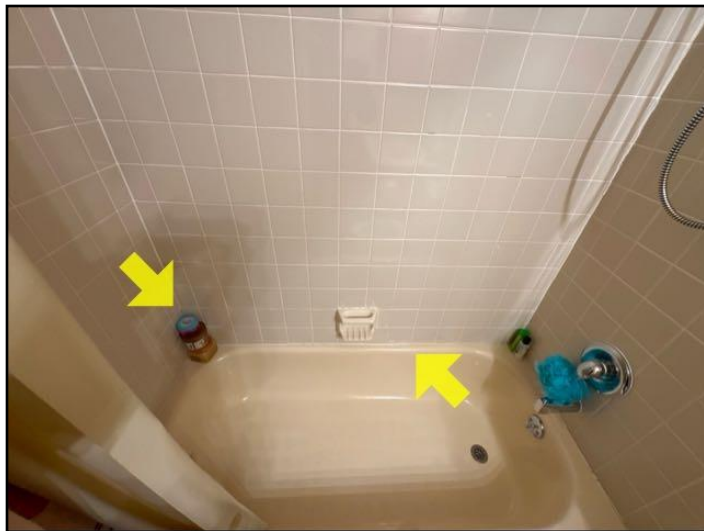
**• Fixtures and faucets\Bathtub enclosure: Grout loose, missing or deteriorated Notes: Deteriorated grout at the hallway bathroom shower**

**109.** Grout loose, missing or deteriorated

**Task:** Repair

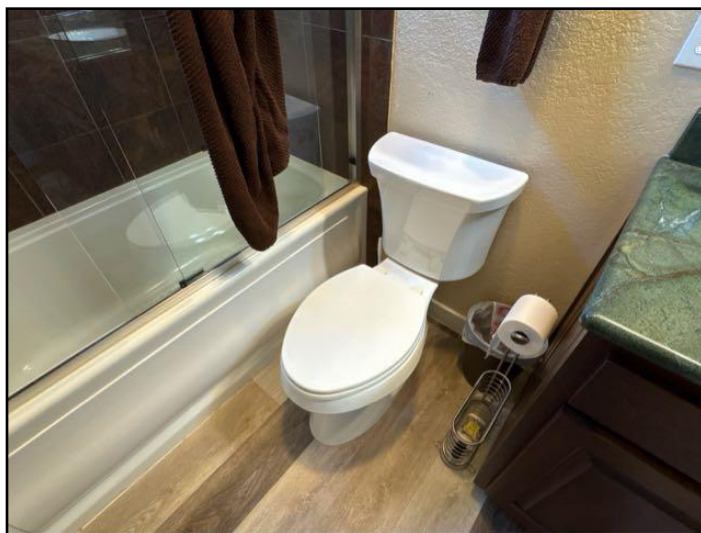
**• Fixtures and faucets\Toilet: Loose Notes: The hallway bathroom toilet was loose**

113. Loose

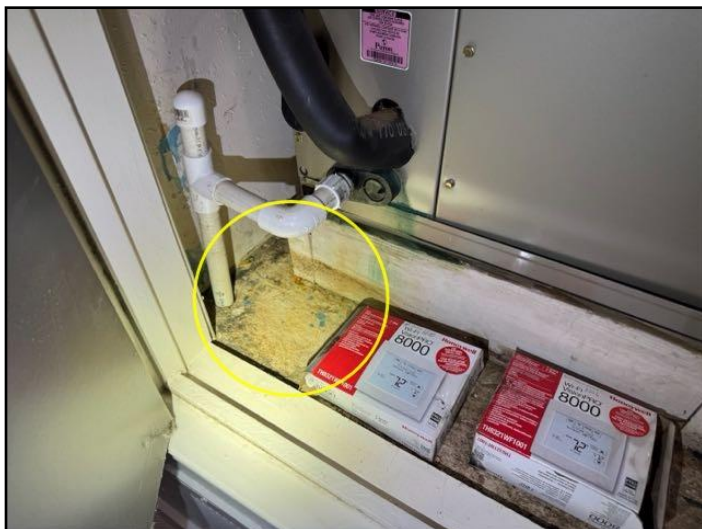
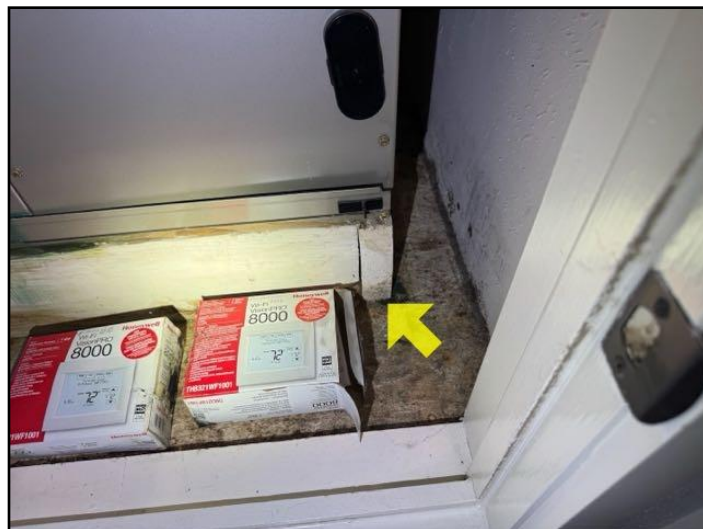
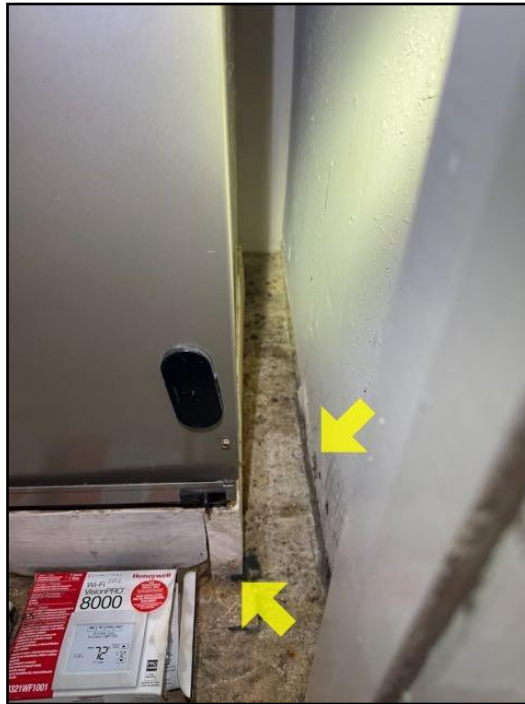
• Walls\Plaster or drywall: **Water damage** Notes: **Water damage at the first floor HVAC closet. No moisture present at the time of the inspection.**

119. Water damage

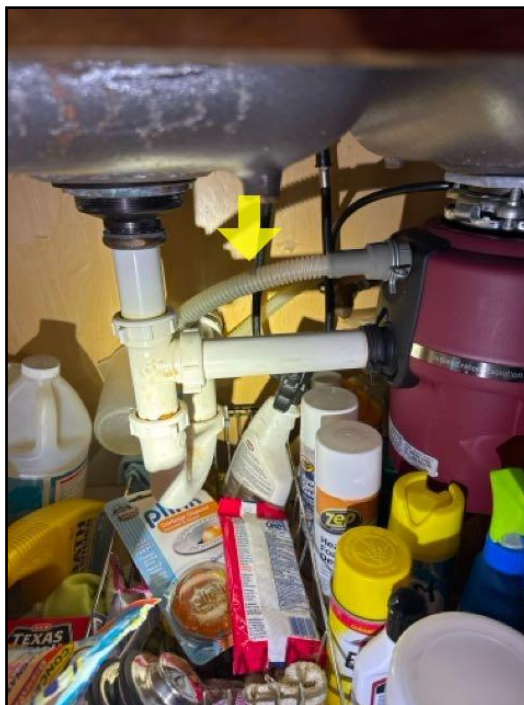
• *Appliances\Dishwasher:* **Backflow prevention high loop missing** *Notes:* **No high loop at the dishwasher to prevent backflow of water into the dishwasher or water siphoning out during operation**

**123.** Backflow prevention high loop missing

**Task:** Repair
