# LIGHTHOUSE ENGINEERING, L.L.C.

Date: Friday, July 21, 2023

RE: Engineering Evaluation – Distress Inventory Report and Structural Performance  
Express Limited Major Structural Defect Warranty

Homeowner - Nicole Neely (Current Homeowner)  
Subject Address: 2121 Pecan Leaf, New Braunfels, TX 78130  
Date of Closing -

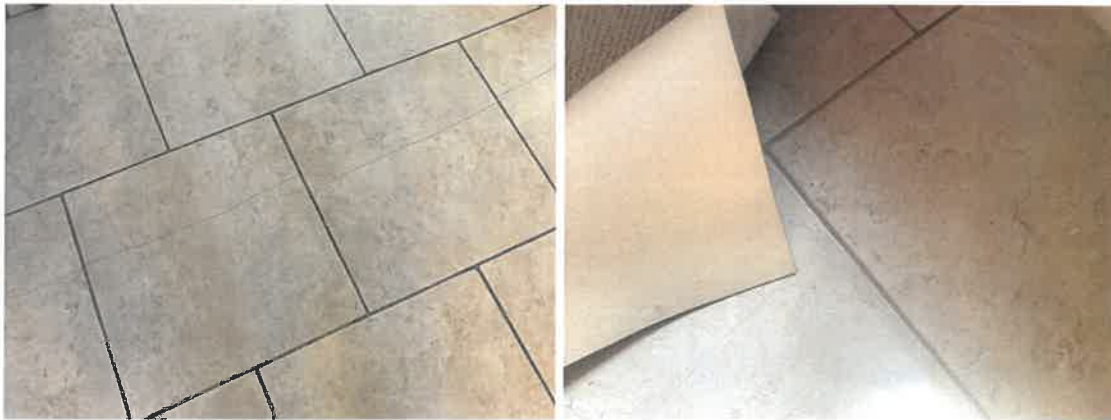
The Homeowner expressed concerns for foundation and/or structural performance as evidenced (primarily) by a tile crack across the bathroom and living room floors. These types of tile cracks are caused from the normal vibrational movements of the foundation and occur along drying cracks in the concrete foundation. These are not indicative of adverse structural damage.

Pictures 1 and 2: Tile cracks.

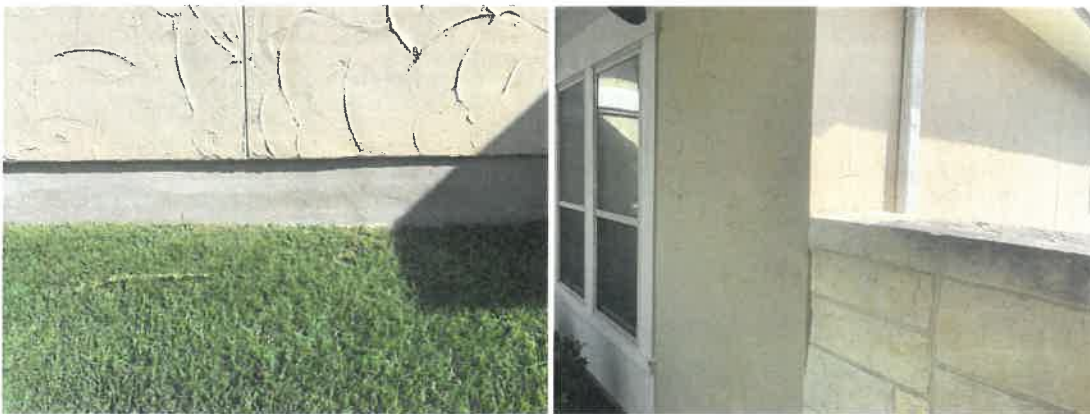
2. There are minor (hairline) foundation cracks identified along the right side. These types of cracks are normal for a concrete foundation of this age and location. These are typically caused from normal thermodynamic concrete shrinkage during the drying process and the normal post-construction vibrational movements of the foundation. These types of cracks are not indicative of foundation distress.

3. The homeowner expressed concern for the front masonry fence subsiding. The footing and fence are not part of the structure of the home. It can be repaired as desired.

Pictures E1 and E2: Minor foundation curing crack. Front fence subsidence.

5. Continue to monitor these cracks as normal seasonal movements.

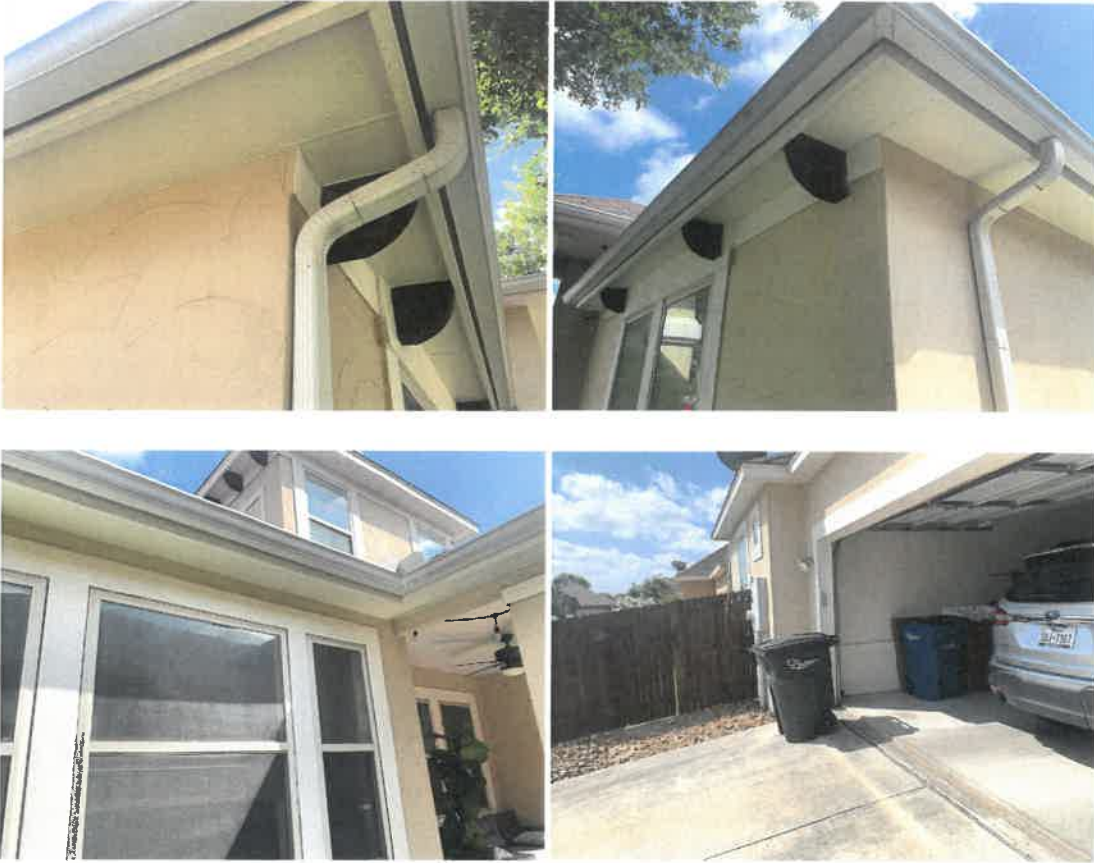
Pictures E3 - E6: General exterior pictures. No distress observed.

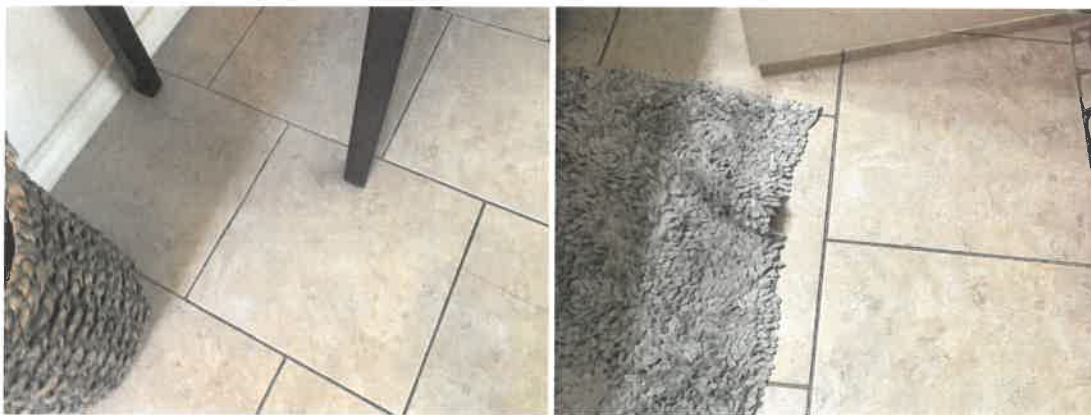
3. There are minor (hairline) tile cracks in the hallway bathroom and in the family room. These types of tile cracks are caused from the normal vibrational movements of the foundation and occur along drying cracks in the concrete foundation. These are not indicative of adverse structural damage.

Pictures I1 and I2: Tile cracks.

6. Continue to monitor these cracks as normal seasonal movements.

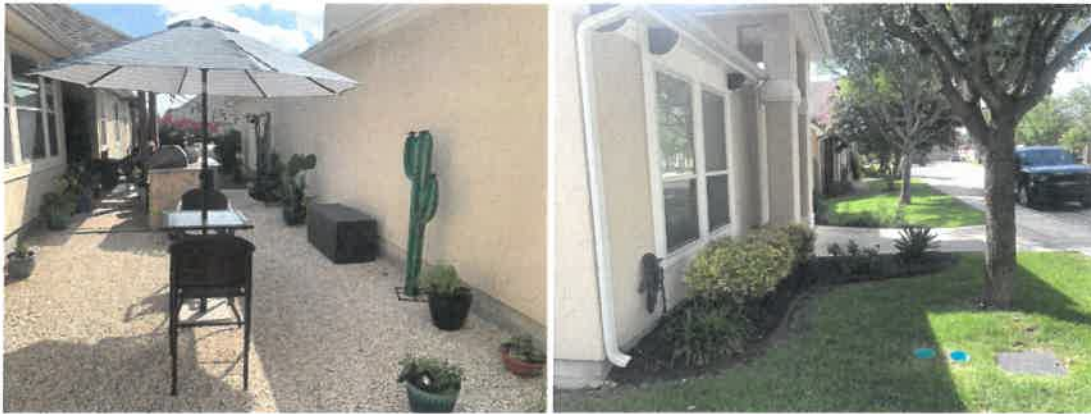
1. The surface drainage was marginal to slightly negative along the left side and along the front.
2. Drainage around the remainder of the perimeter is positive away from the foundation.
3. Surface drainage was concluded to not be a contributing factor to the overall foundation performance.
4. The perimeter of the home is equipped with gutters. It is recommended to routinely maintain the gutters and downspouts to ensure proper flow away from the home's foundation. No standing water was identified around the home's foundation.

Pictures D1 and D2: Drainage along the left and front.

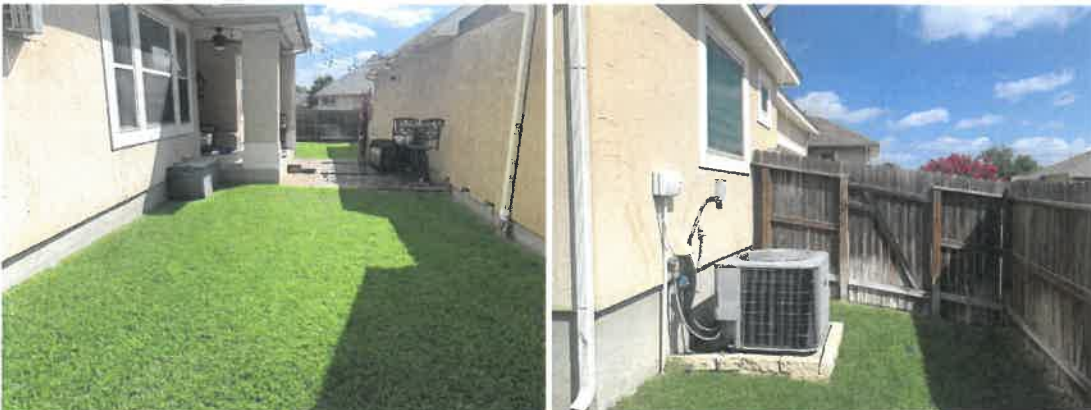
Pictures D3 and D4: Drainage along the right and rear.

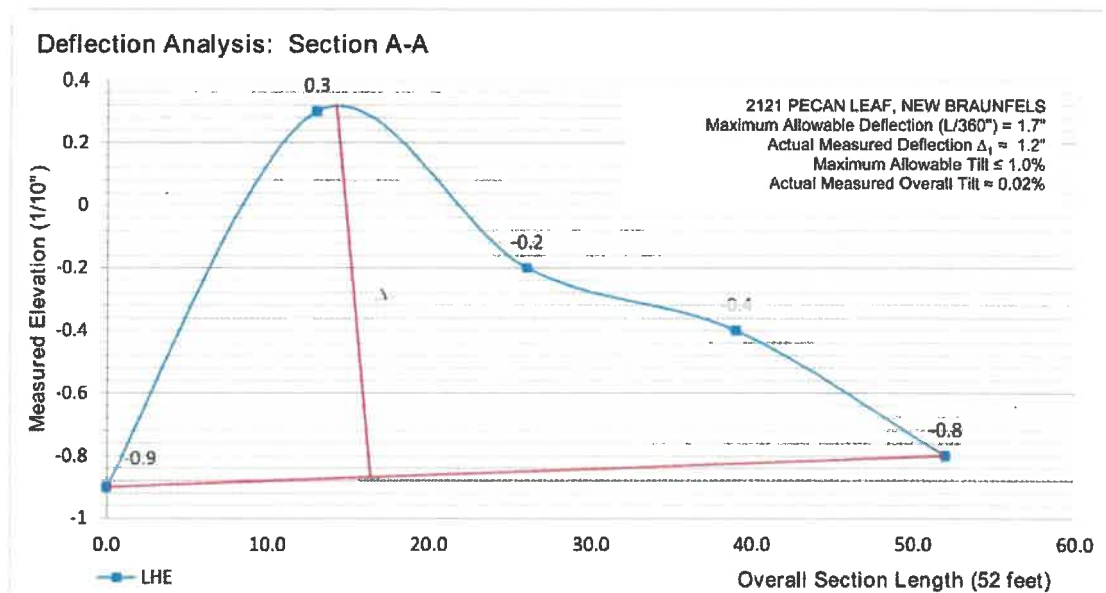
Figure 1: Deflection Analysis Across Section A-A

- The allowable edge-to-edge deflection is  $\Delta_1 = L/360" = 52 \text{ feet } (624)" / 360" = 1.7"$
- The actual edge-to-edge deflection measured is  $\Delta_1 \approx 1.2"$   
This is within the ASCE guideline tolerance of  $L/360$  for foundation deflection.
- The actual edge-to-edge tilt measured is  $\approx 0.02\%$   
This is within the ASCE guideline tolerance of 1.0% for foundation tilt.
