CONCERNING THE PROPERTY AT 13402 Turnesa Terrace, San Antonio, TX 78221

TREC REI 7-6

13402 Turnesa Ter  
San Antonio, TX 78221

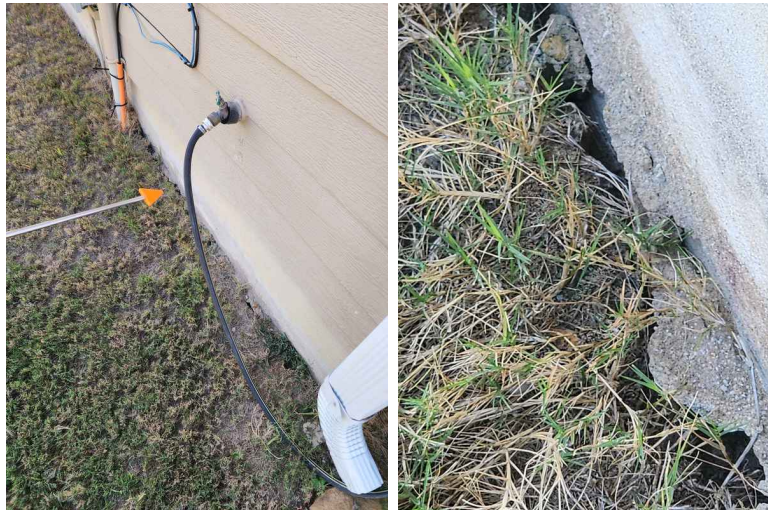
The soil around the foundation perimeter wall was found to be pulling away from the foundation wall (shrinkage). If left unattended, this situation could worsen causing the foundation to move, shift, and settle oddly.

Recommendation: Contact a qualified professional.

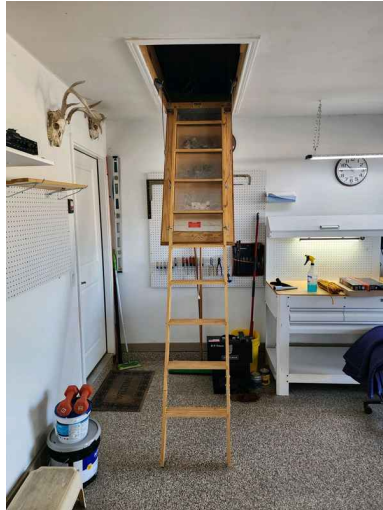
*Viewed From: Attic -*

The visible area of the roof structure and attic were inspected according to today's Texas standards of practice.

*Approximate Average Depth of Insulation:* 11 Loose Fill Cellulose

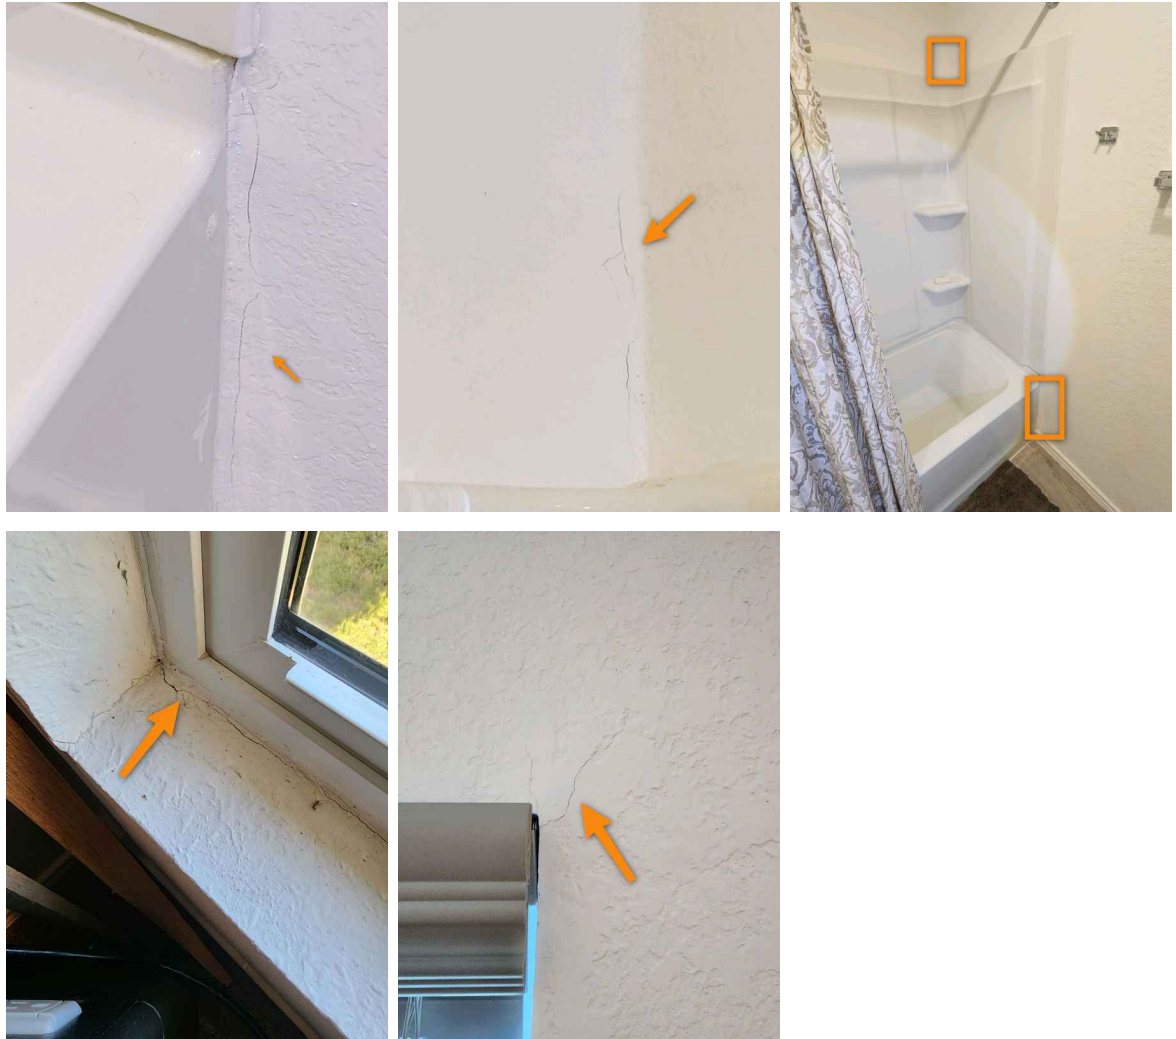
**1: Cracks - Minor**

Minor cracking was observed in wall structure. Recommend monitoring & repair accordingly.

Recommendation: Recommended DIY Project

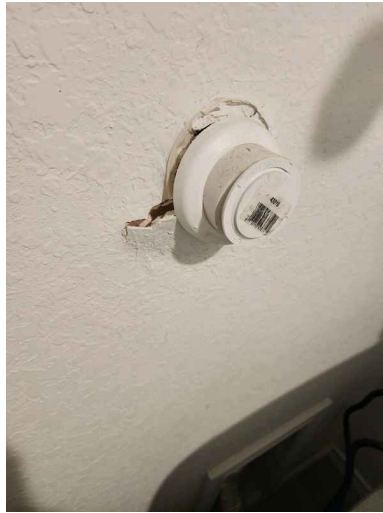
## 2: Damaged Drywall

Damaged drywall was observed in the home. Damaged drywall should be repaired to prevent further deterioration.

Recommendation: Contact a handyman or DIY project

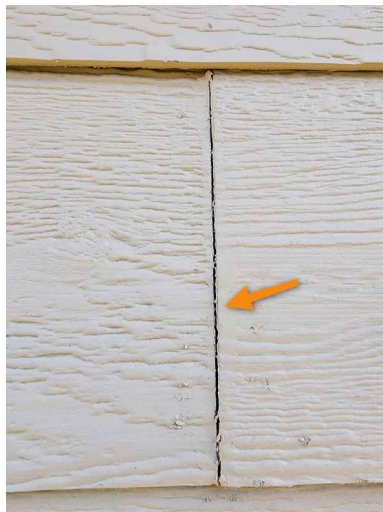
### 3: Siding - Sealant

The siding needs sealant on butt-joints. This will help prevent water damage and deterioration.

Throughout exterior wall

Recommendation: Contact a qualified professional.

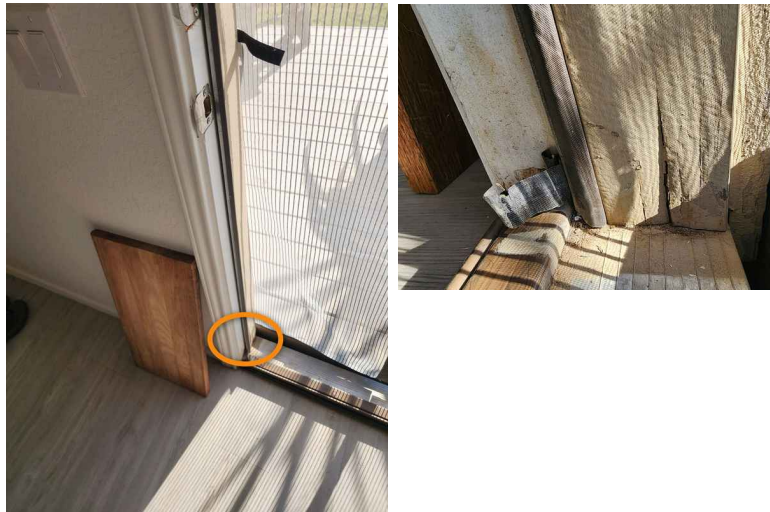
**1: Damaged/ Deteriorated Door Trim**

Damaged and or deteriorated door trim was observed. Monitor and repair accordingly.

Recommendation: Contact a qualified professional.

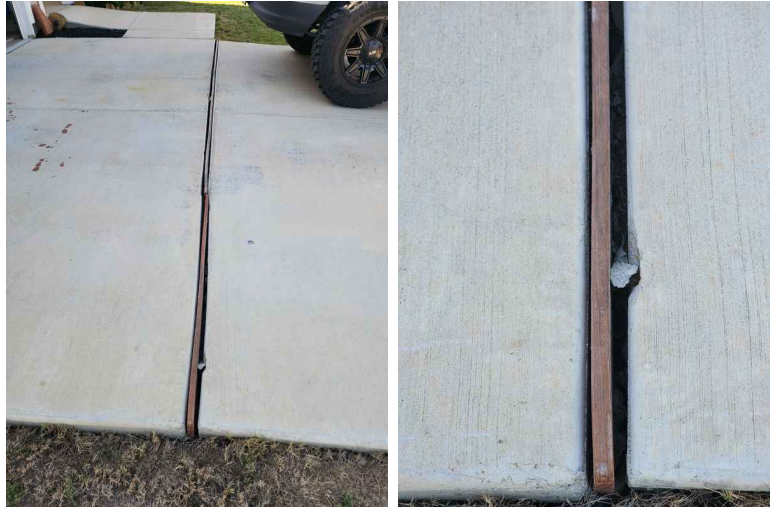
Differential movement of the flat work such as driveways, walkways, & patio was observed. Differential movement in flatwork may be an indication of movement, settlement or other defects and should be repaired

as **needed**. Monitor and repair accordingly.

Recommendation: Contact a qualified professional.

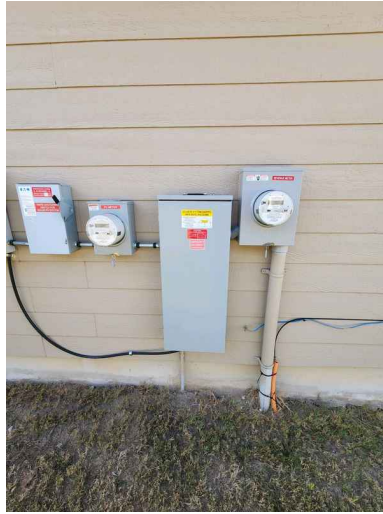
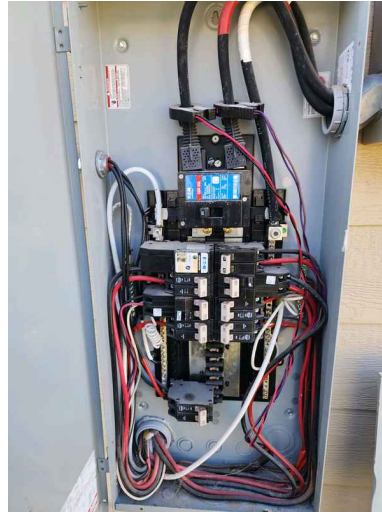
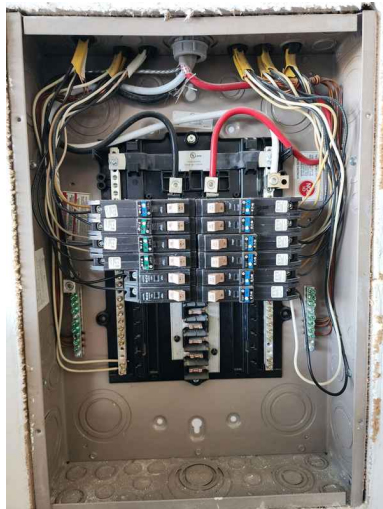
The main electrical service entrance and service panel was inspected according to today's Texas standards of practice and was performing as intended at the time of the inspection.

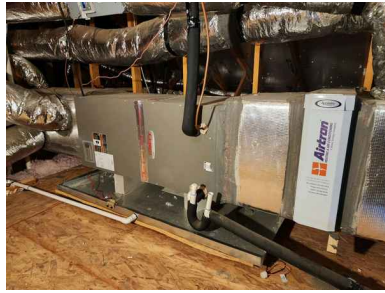
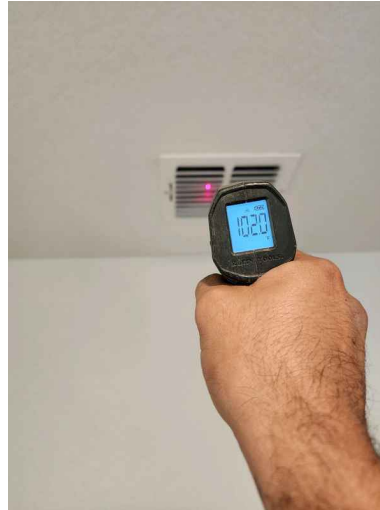
*Type of Systems:* Heat Pump -

The heating equipment was inspected according to today's Texas standards of practice.

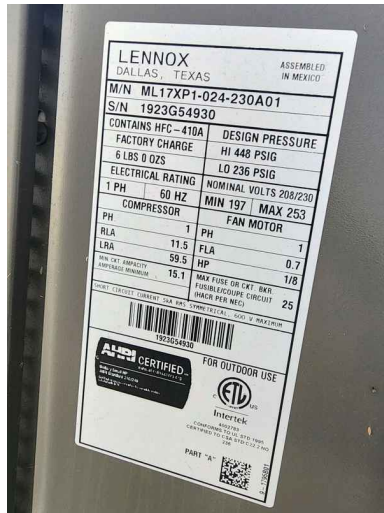
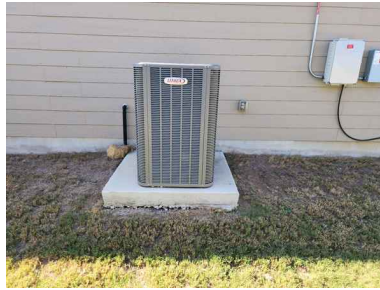
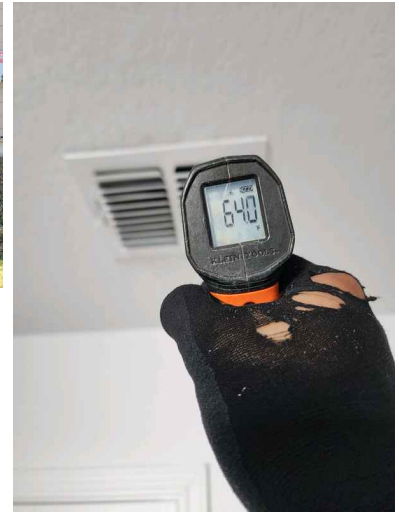
The cooling equipment was inspected according to today's Texas standards of practice and was performing as intended at the time of inspection.

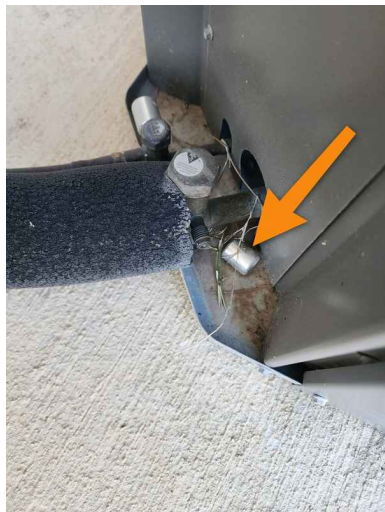
**1: Missing Locking Caps**

The locking caps are missing or have not been installed of HVAC coolant ports.

As of 2009, any & all HVAC systems are required to have locking caps on all units in residential or commercial property. Residents are subject to significant fines. Only a licensed HVAC company may install or remove.

Recommendation: Contact a qualified HVAC professional.

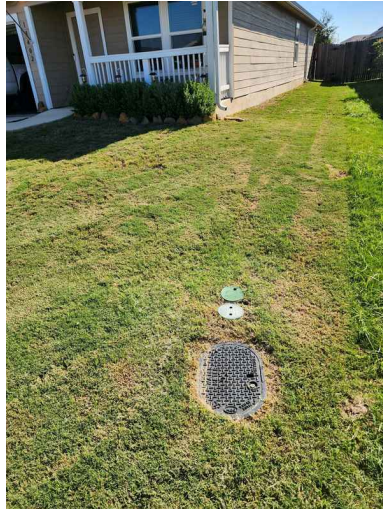
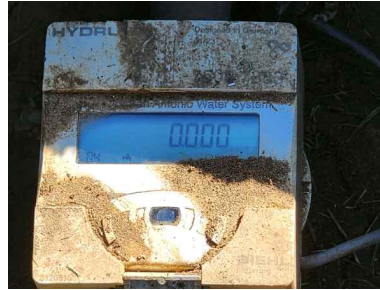
*Location of Water Meter:* Exterior

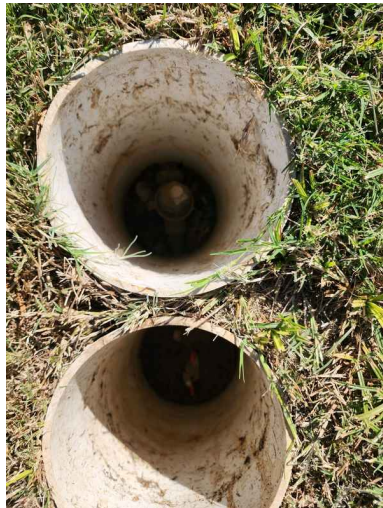
*Location of Main Water Supply Valve :* Next to Meter, Pressure Regulator - Located next to Meter

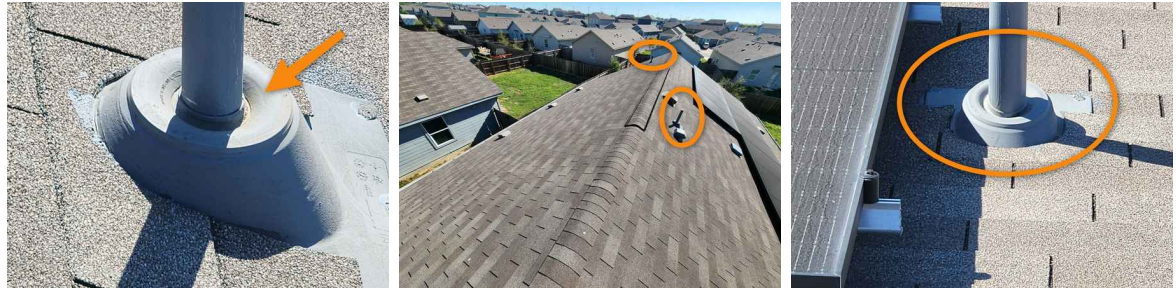
#### 1: Roof Penetration Boot Deficient

A roof penetration plumbing boot was found to be deficient. The boot is concaved and will allow water to collect. This will then cause the boot to deteriorate quicker and allow for possible water intrusion.

Recommendation: Contact a qualified professional.

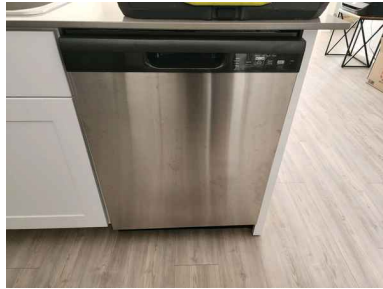
The dishwasher was inspected according to today's Texas standards of practice and was performing as intended at the time of inspection.

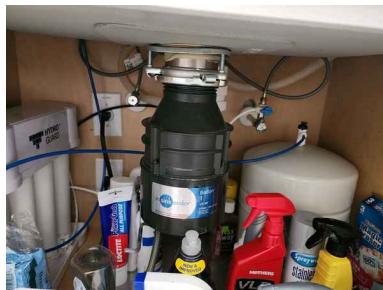
The food waste disposer was inspected according to today's Texas standards of practice and was performing as intended at the time of inspection.

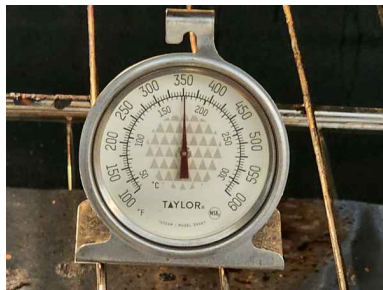
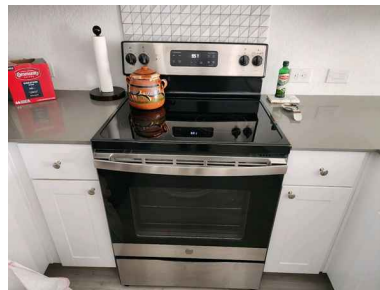
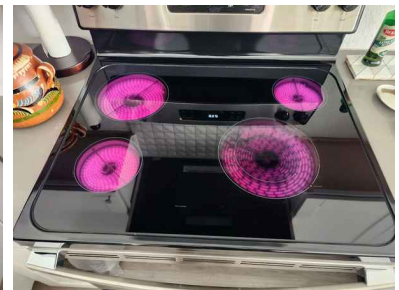
The range/cooktop was inspected according to today's Texas standards of practice and was performing as intended at the time of inspection.

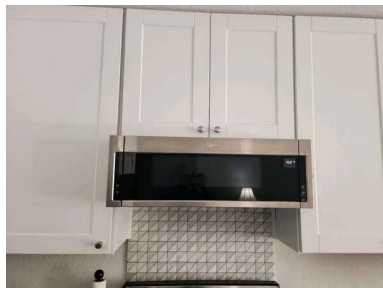
The microwave was inspected according to today's Texas standards of practice And Was performing as intended at the Time of inspection.
