TREC REI 7-6

# PROPERTY INSPECTION REPORT FORM

13402 Turnesa Ter, San Antonio, TX 78221

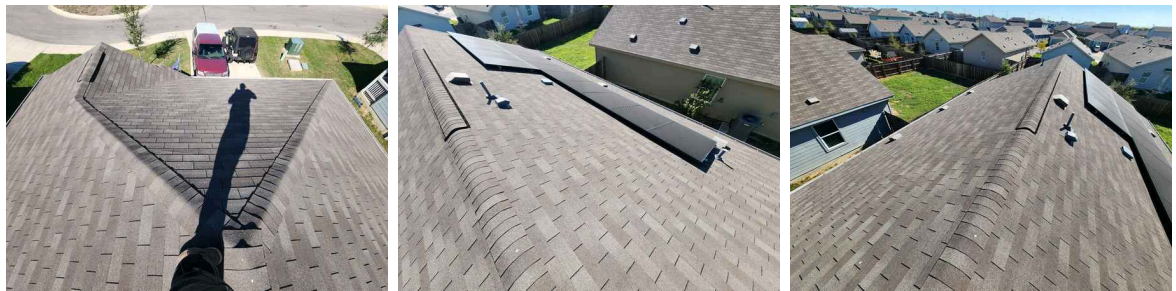
*Roof Inspection Method* : Walked Roof

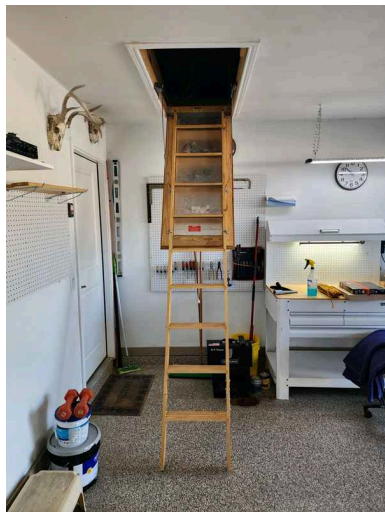
*Viewed From: Attic -*

The visible area of the roof structure and attic were inspected according to today's Texas standards of practice.

*Approximate Average Depth of Insulation:* 11 Loose Fill Cellulose

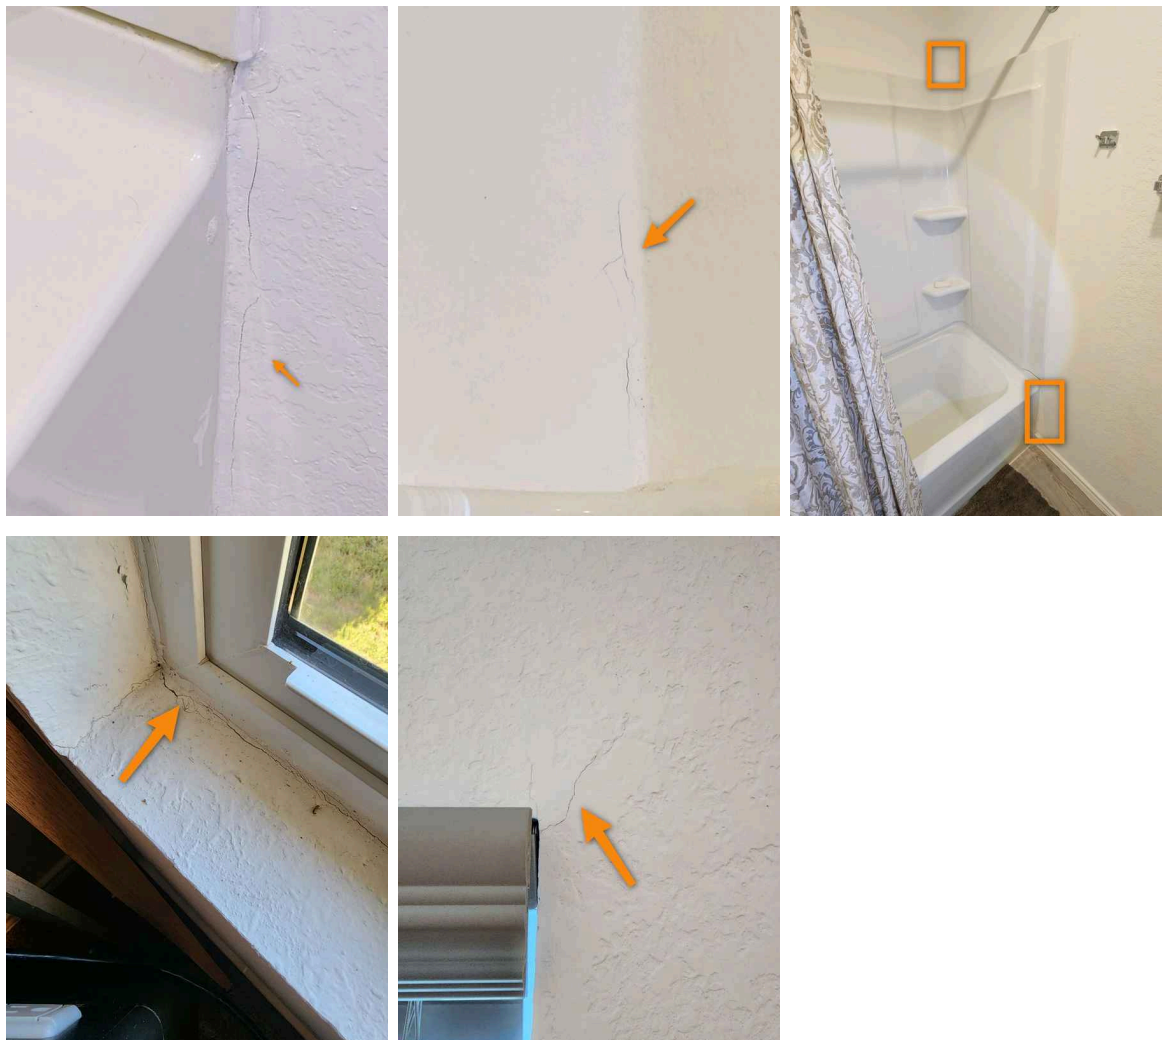
**1: Cracks - Minor**

Minor cracking was observed in wall structure. Recommend monitoring & repair accordingly.

Recommendation: Recommended DIY Project

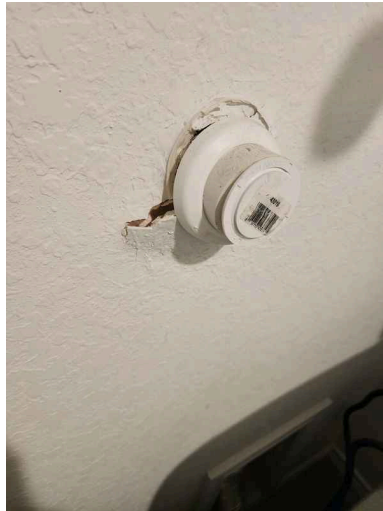
## 2: Damaged Drywall

Damaged drywall was observed in the home. Damaged drywall should be repaired to prevent further deterioration.

Recommendation: Contact a handyman or DIY project

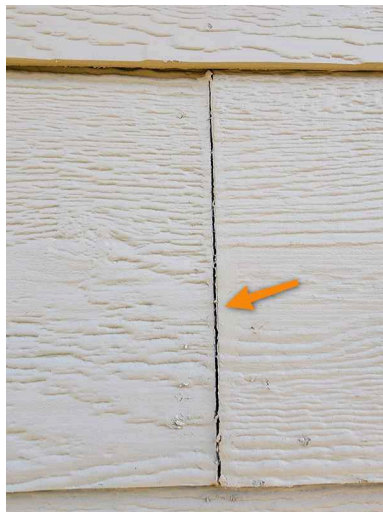
### 3: Siding - Sealant

The siding needs sealant on butt-joints. This will help prevent water damage and deterioration.

Throughout exterior wall

Recommendation: Contact a qualified professional.

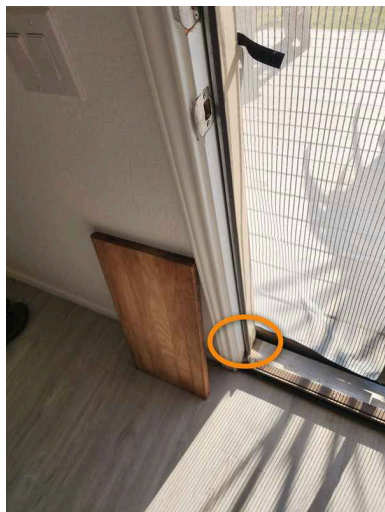
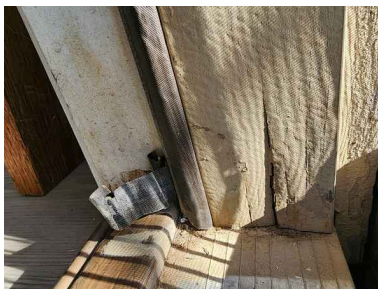
**1: Damaged/ Deteriorated Door Trim**

Damaged and or deteriorated door trim was observed. Monitor and repair accordingly.

Recommendation: Contact a qualified professional.

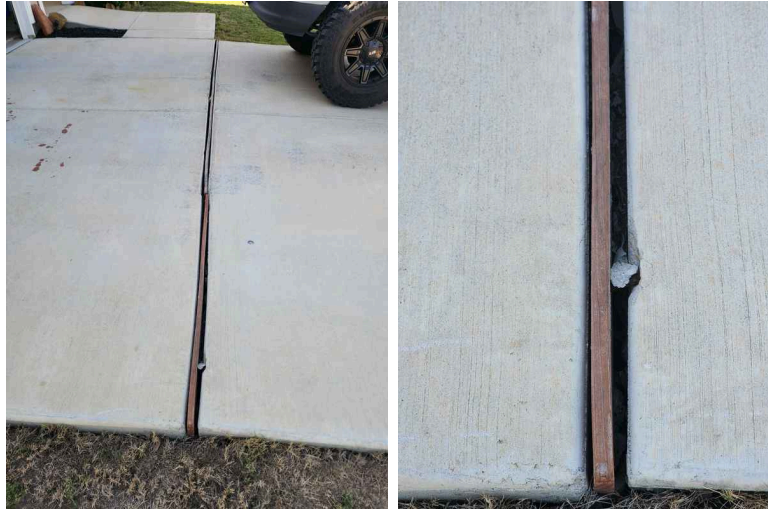
**1: Differential Movement in Flatwork**

Differential movement of the flat work such as driveways, walkways, & patio was observed. Differential movement in flatwork may be an indication of movement, settlement or other defects and should be repaired

as **needed**. Monitor and repair accordingly.

Recommendation: Contact a qualified professional.

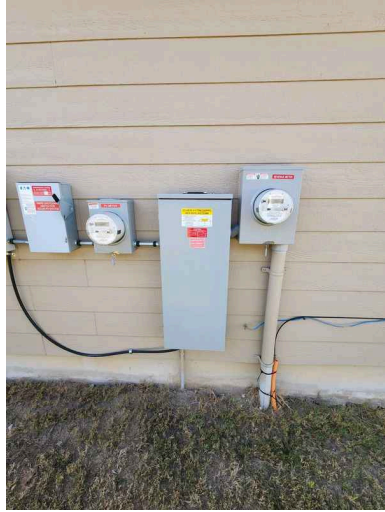
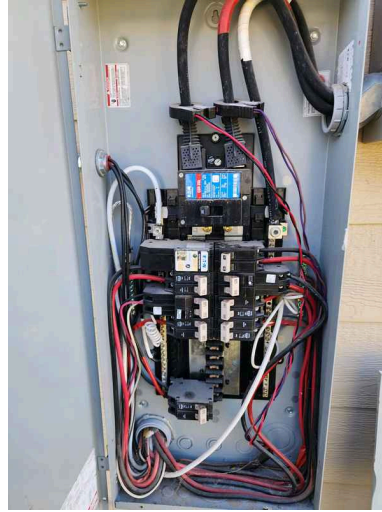
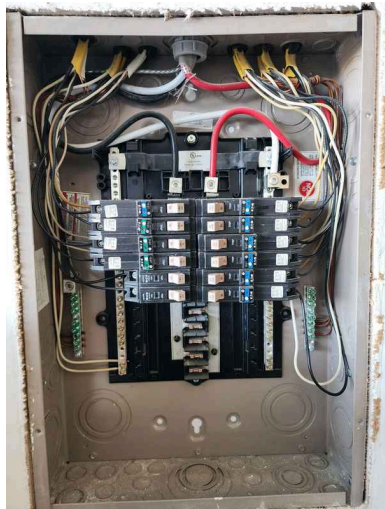
The main electrical service entrance and service panel was inspected according to today's Texas standards of practice and was performing as intended at the time of the inspection.

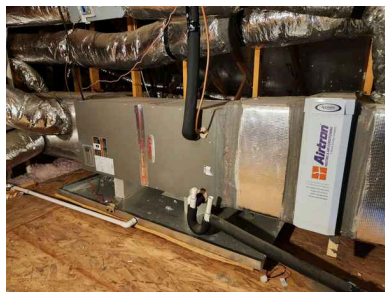
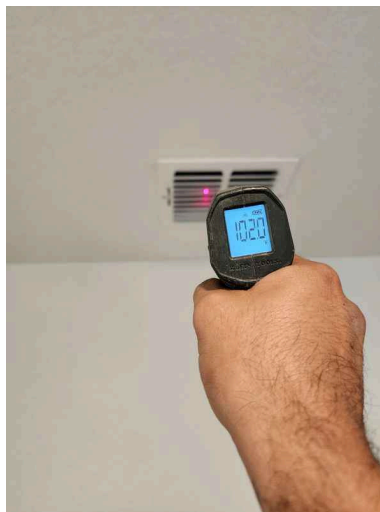
*Type of Systems:* Heat Pump -

The heating equipment was inspected according to today's Texas standards of practice.

*Energy Sources:* Electric

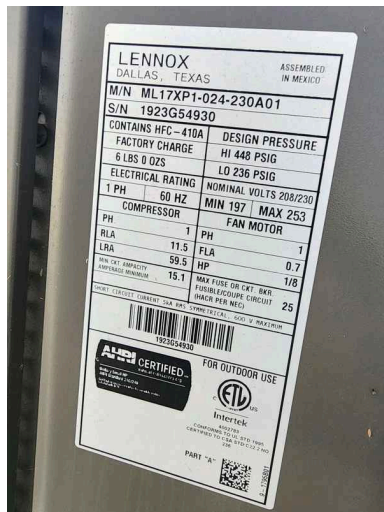
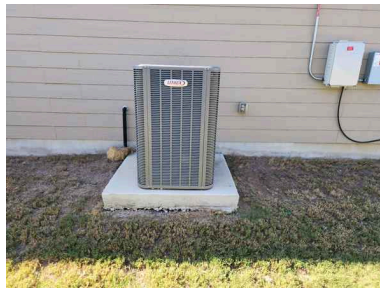
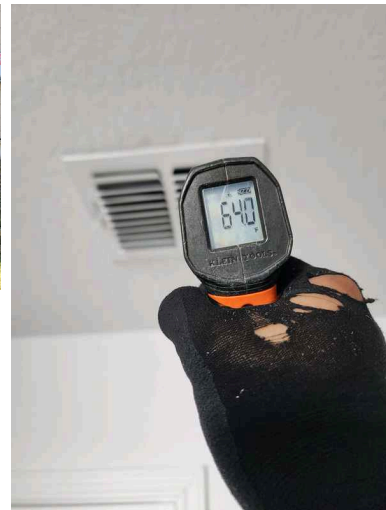
The cooling equipment was inspected according to today's Texas standards of practice and was performing as intended at the time of inspection.

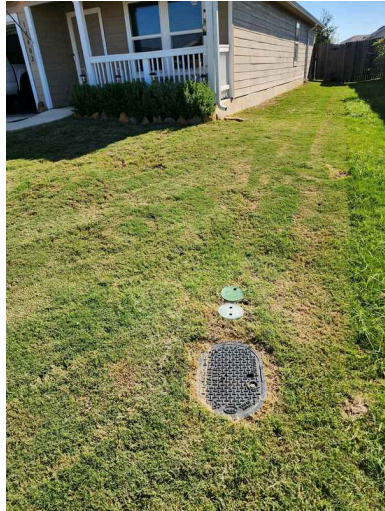
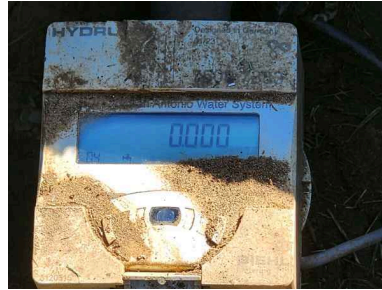
*Location of Water Meter: Exterior*

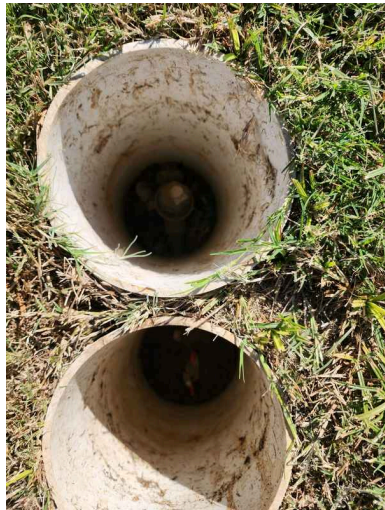
*Location of Main Water Supply Valve : Next to Meter, Pressure Regulator - Located next to Meter*

*Static Water Pressure Reading: 50*

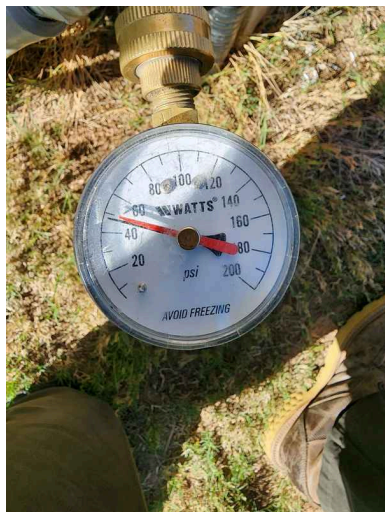
*Type of Supply Piping Material:* PEX

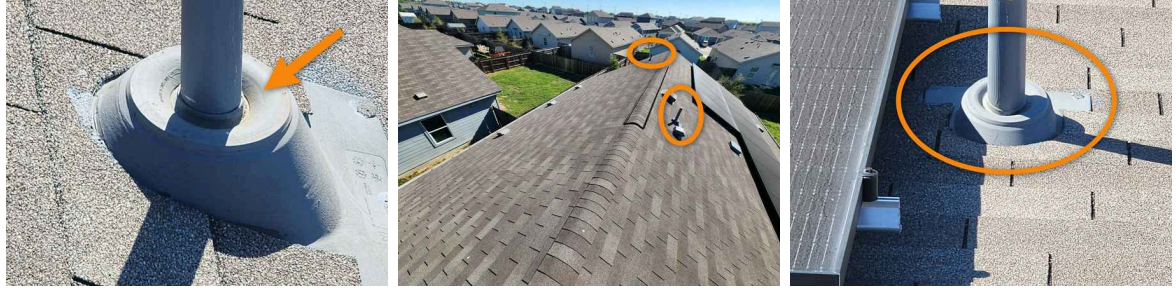
#### 1: Roof Penetration Boot Deficient

A roof penetration plumbing boot was found to be deficient. The boot is concaved and will allow water to collect. This will then cause the boot to deteriorate quicker and allow for possible water intrusion.

Recommendation: Contact a qualified professional.

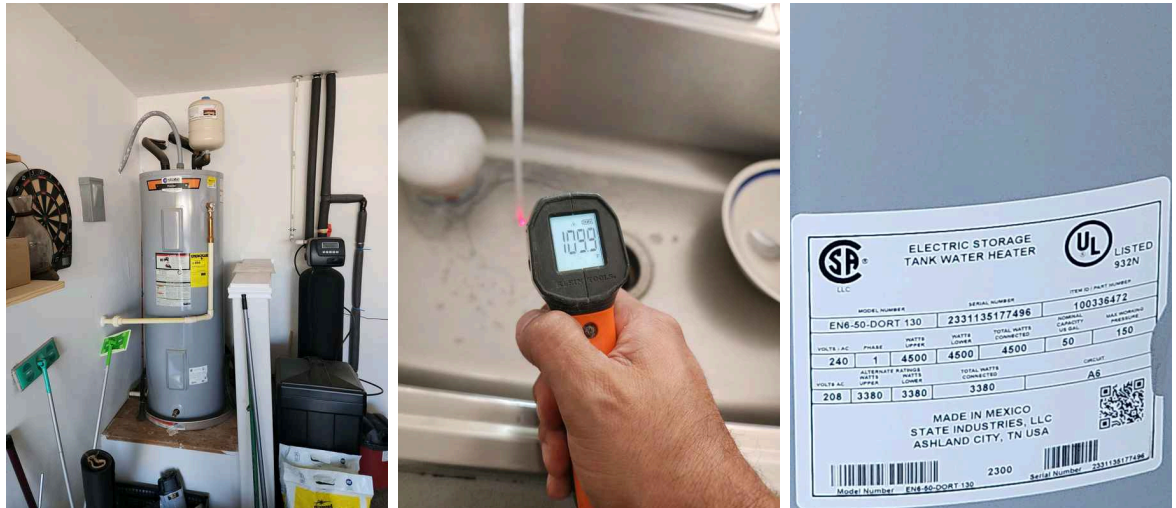
**1: Annual Maintenance Flush Needed**

Water heaters should be flushed annually or during change of ownership to prevent sediment buildup and maintain efficiency.

This popping noise means there's sediment (mineral deposits) at the bottom of the water heater tank. Water under the sediment is steaming and bubbling up, pushing the sediment around and causing the popping noise.

Recommend a qualified plumber service and flush.

Recommendation: Contact a qualified plumbing contractor.

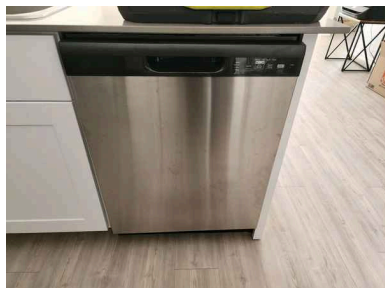
The dishwasher was inspected according to today's Texas standards of practice and was performing as intended at the time of inspection.

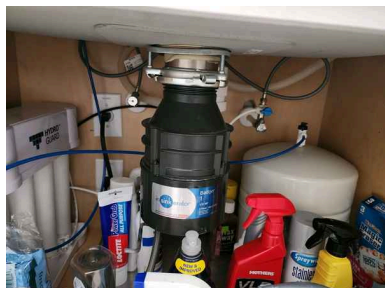
The food waste disposer was inspected according to today's Texas standards of practice and was performing as intended at the time of inspection.

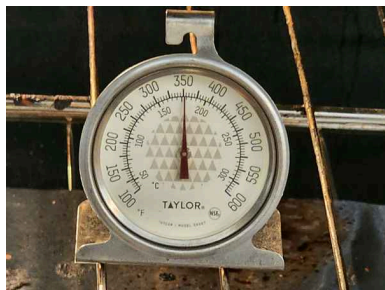
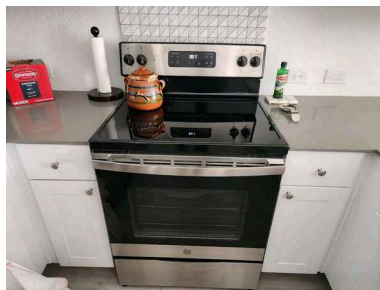
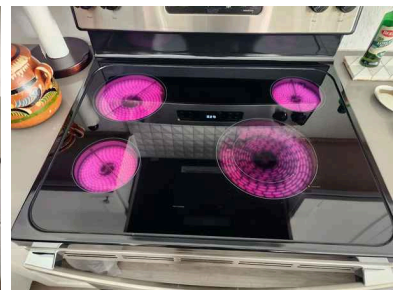
The range/cooktop was inspected according to today's Texas standards of practice and was performing as intended at the time of inspection.

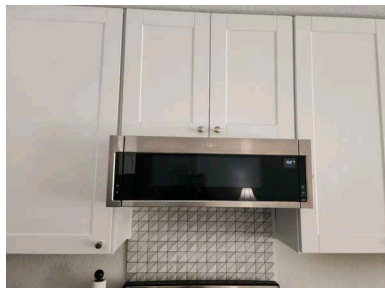
The microwave was inspected according to today's Texas standards of practice And Was performing as intended at the Time of inspection.
