# Your Inspection Report

2051 Phantom Rider Trl  
Spring Branch, TX 78070

**INSPECTION DATE:**  
Monday, February 23, 2026

**PREPARED BY:**  
Casey Herbert, 24484

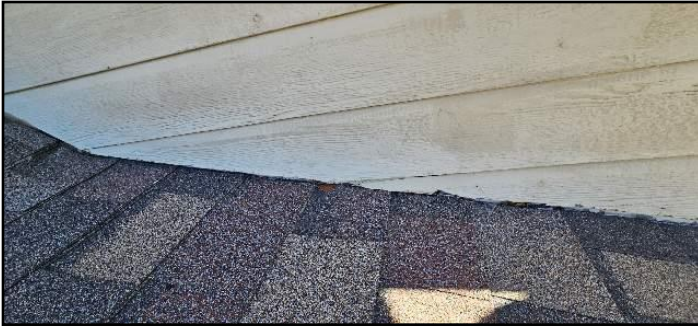
• Sloped roof flashings\Roof/wall flashings: **Siding not cut back** Notes: Siding should be cut at the roof to wall intersection to prevent wicking, rot and deterioration of the siding.

18. Siding not cut back

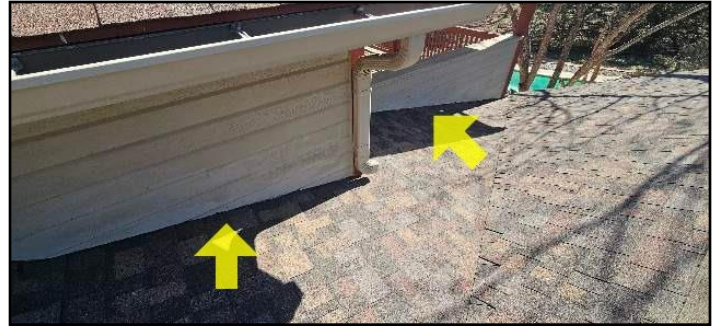
19. Siding not cut back

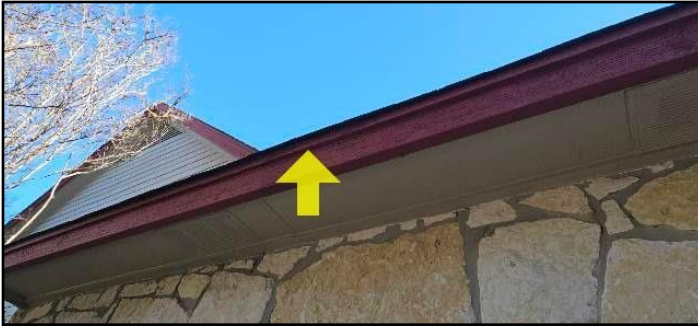
• Sloped roof flashings\Drip edge flashings: **Missing** Notes: No drip edge flashing installed at the front of the house at the time of the inspection. A drip edge is a metal flashing that is installed at the edges of the roof to help control the flow of water away from the fascia and to protect the underlying roofing components.

20. No drip edge

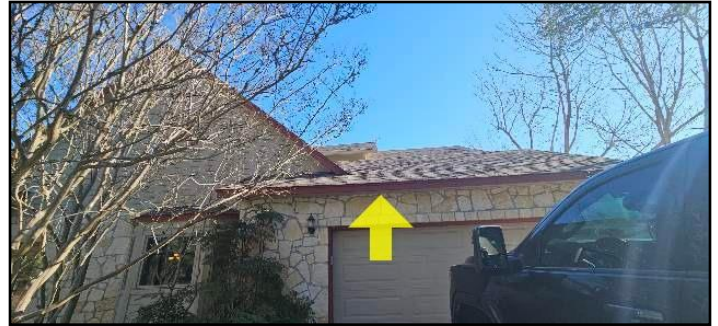
21. No drip edge

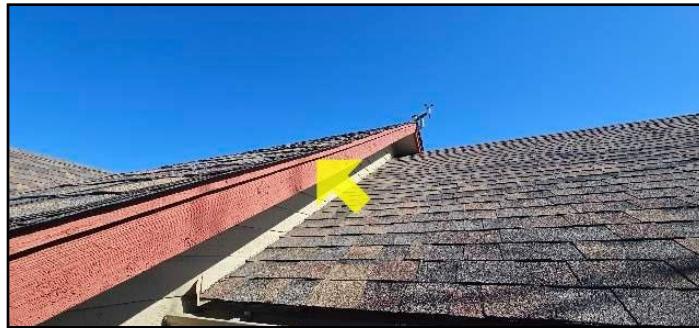
22. No drip edge

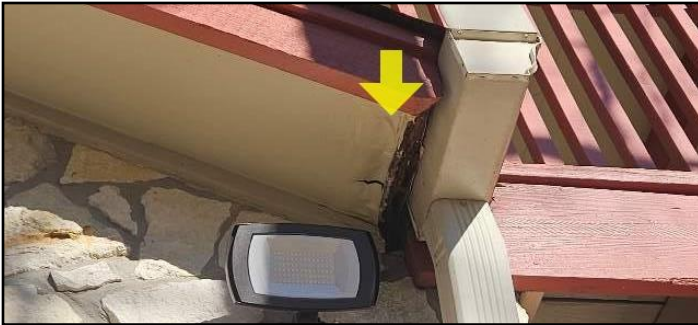
23. Rot

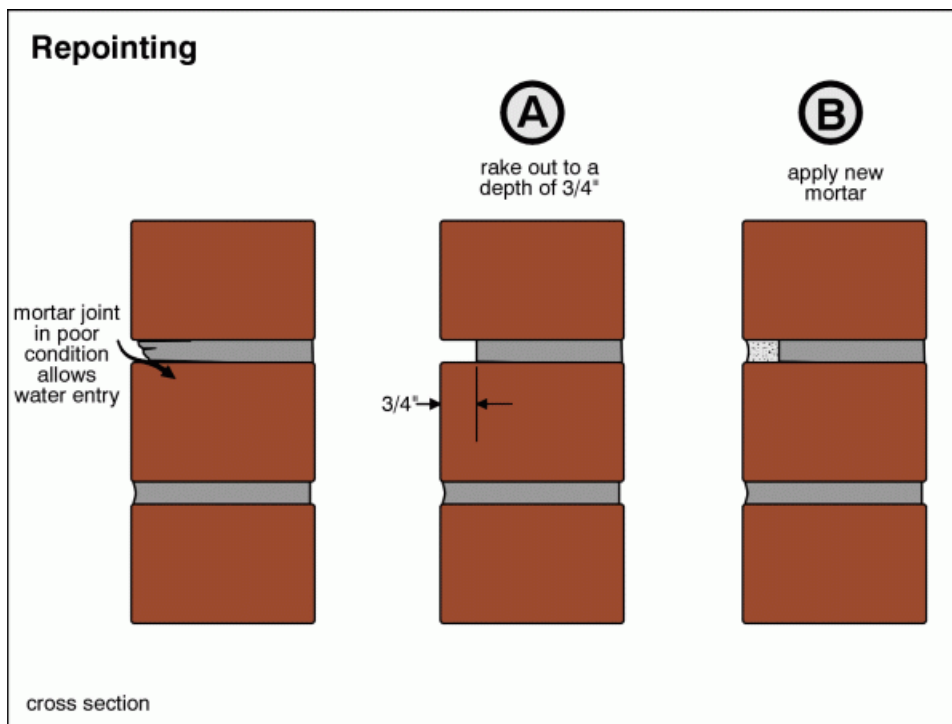
34. Mortar deterioration

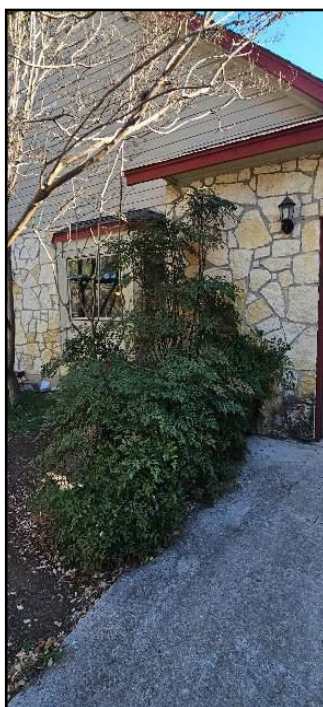
• Landscaping\General notes: **Trees or shrubs too close to building** Notes: Shrubs/trees touching the house can create conducive conditions for pests

37. Trees or shrubs too close to building

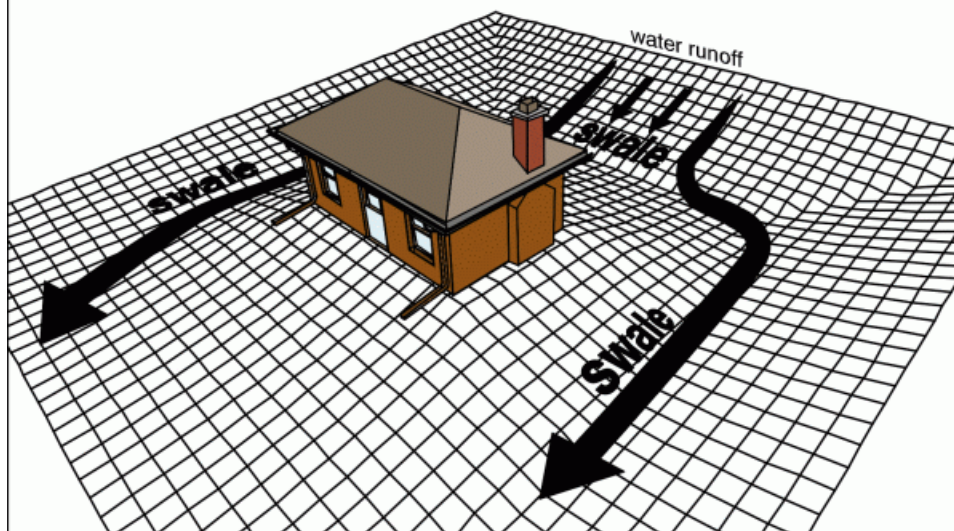
• Landscaping\Lot grading: **Improper slope or drainage** Notes: Improper grading at multiple areas around the house causing water ponding next to the foundation. The inspector recommends repair to prevent structural damage.

38. Improper slope or drainage

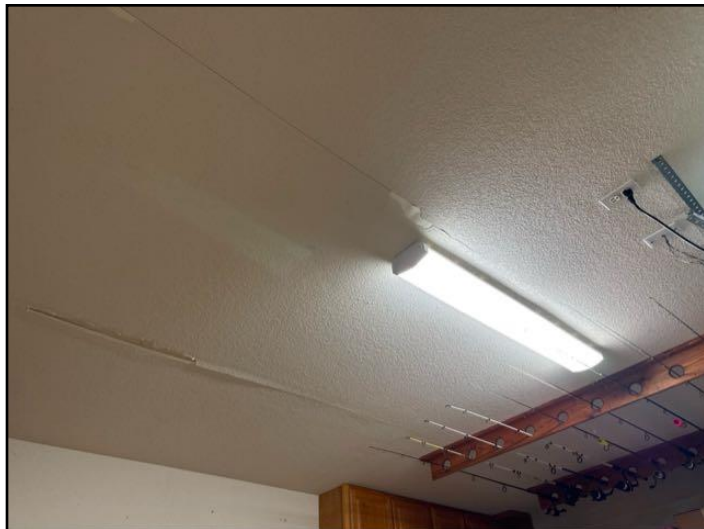
• Foundations\General notes: **Settled** Notes: The foundation is settled and has elevation changes that appear to be within tolerance. Interior cracking ceiling and walls is an indication of structural settlement. The inspector recommends repair to the exterior grading and drainage to prevent structural damage.

56. Settled

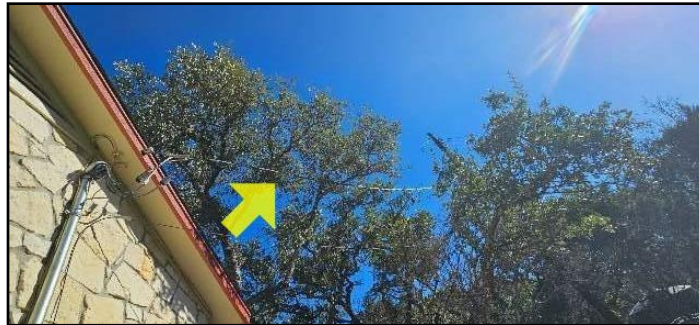
65. Branches / vines interfering with wires

15. Condition: • [Branches / vines interfering with wires](#)

Recommend having the trees trimmed by a qualified contractor

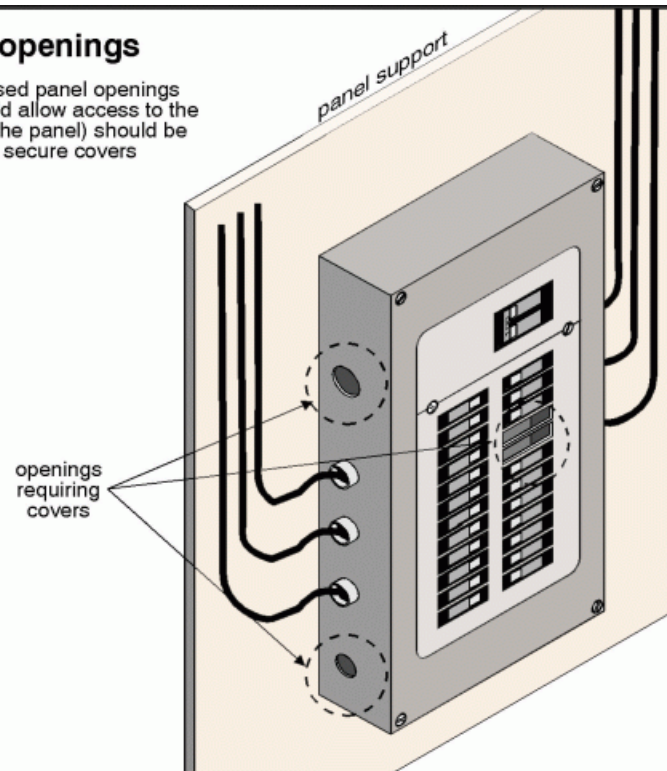
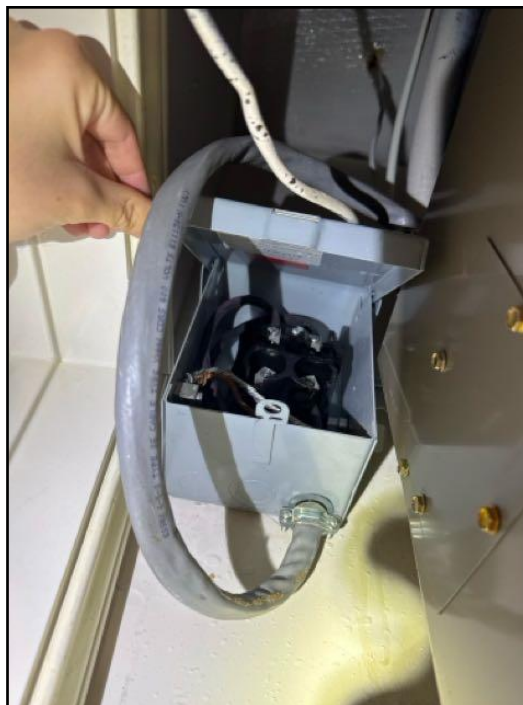
66. Unprotected openings

16. Condition: • [Unprotected openings](#)

any exposed panel openings (that would allow access to the inside of the panel) should be fitted with secure covers

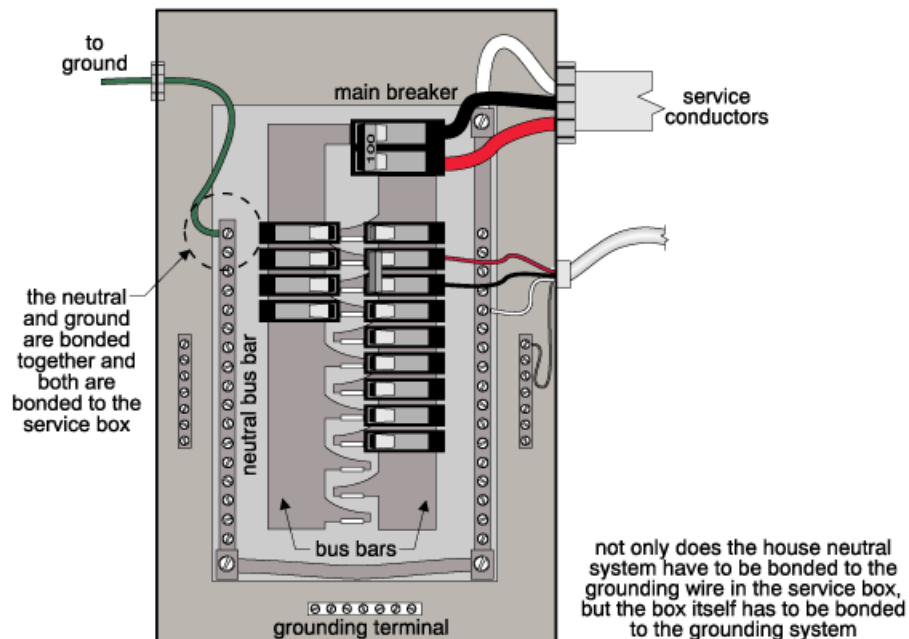
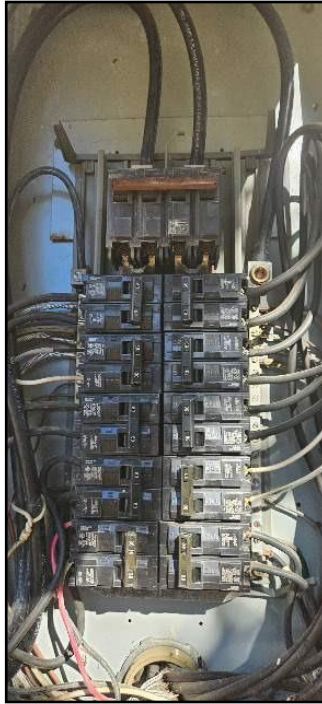
67. Box not bonded to ground

17. Condition: • [Box not bonded to ground](#)

## Bond service box to ground

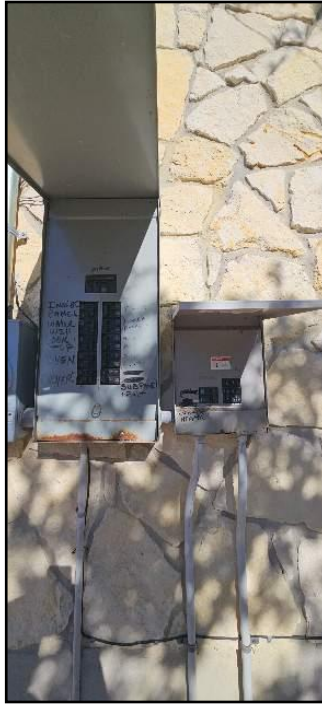
68. Circuits not labeled

### 18. Condition: • [Circuits not labeled](#)

The main electrical panel is not labeled. Recommend having a licensed electrician label all breakers

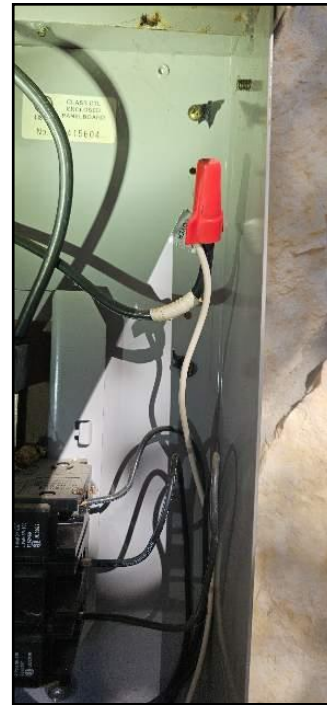
**72.** Non standard installation of the neutral wire

**20. Condition:** • The auxiliary panel neutral wire decreases in size and is not landed on a neutral bus bar inside the panel. Recommend repair by a qualified electrical contractor

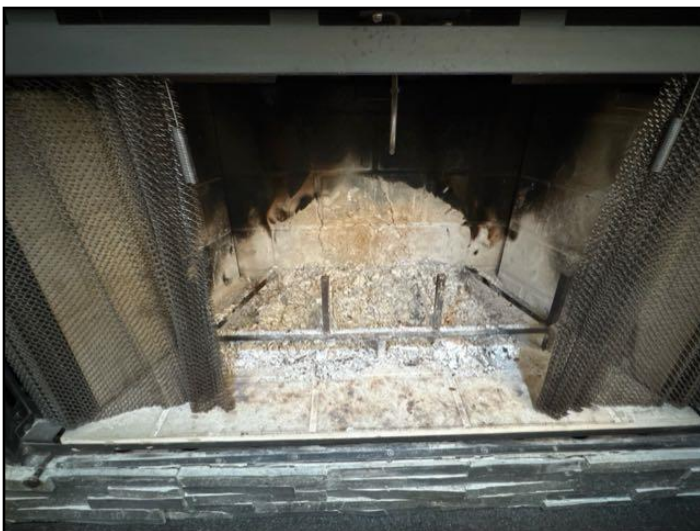
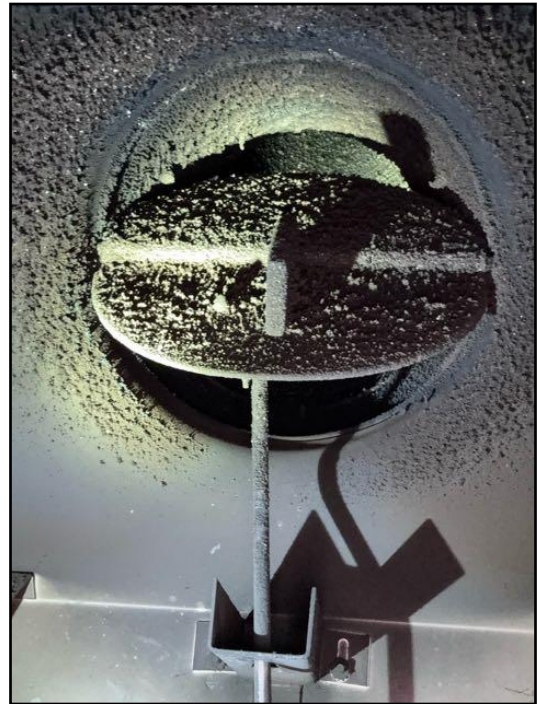
88. Inspect chimney, and sweep, if needed befor...

30. Condition: • [Inspect \(and/sweep if needed\) before using](#)

The fireplace flue is dirty, recommend cleaning/sweeping.

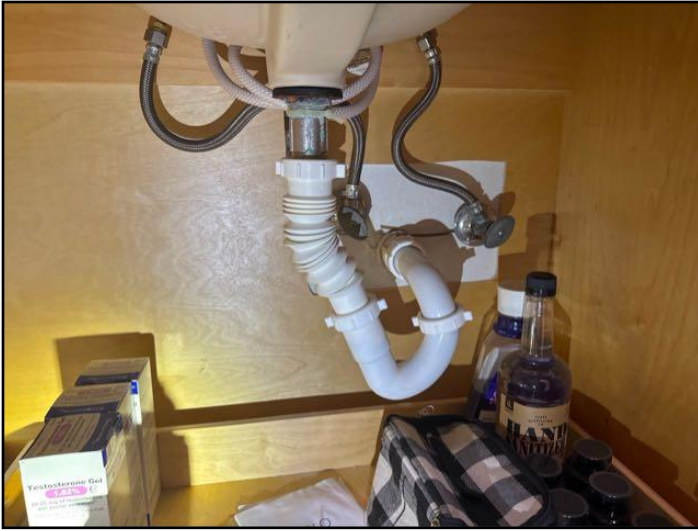
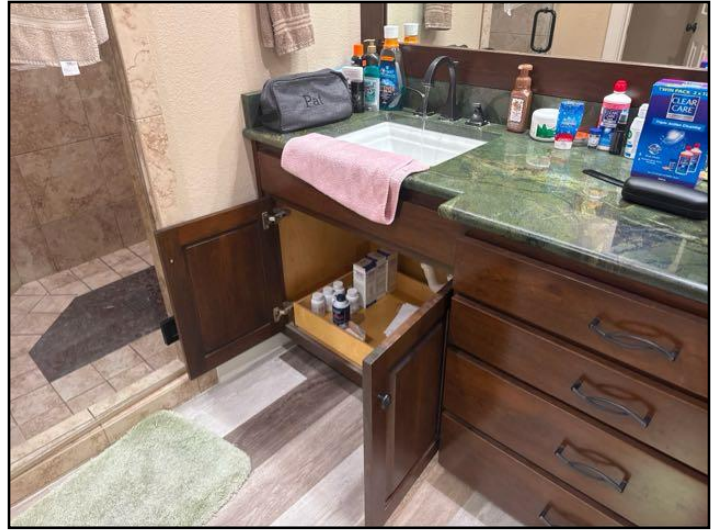
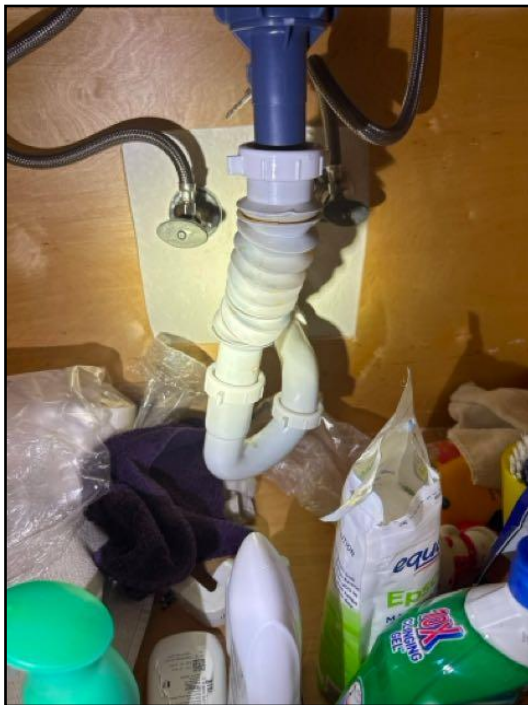
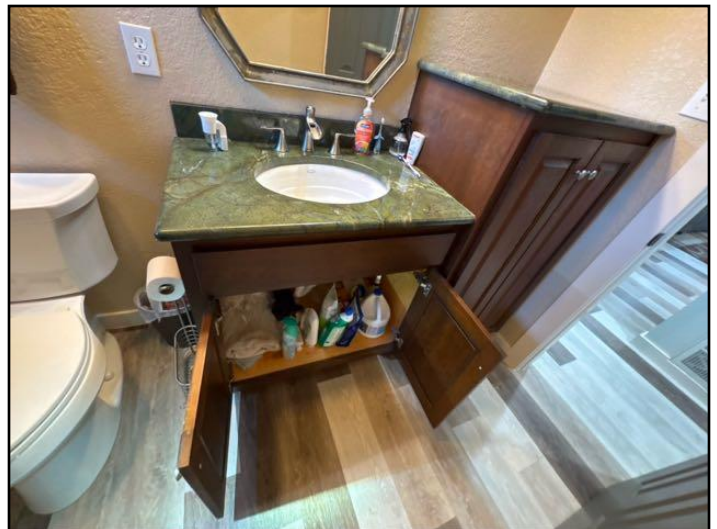
**36. Condition:** • [Nonstandard materials and patches](#)

Flexible drain piping is prone to clogging and leakage.

103. Nonstandard materials and patches

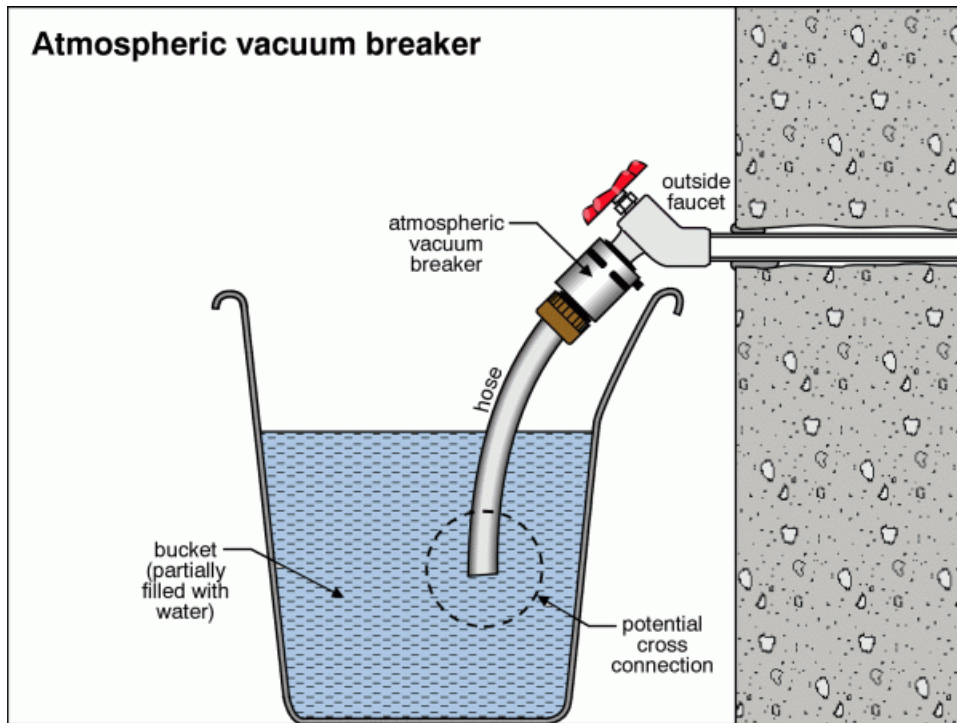
**38. Condition:** • [Backflow prevention missing](#)

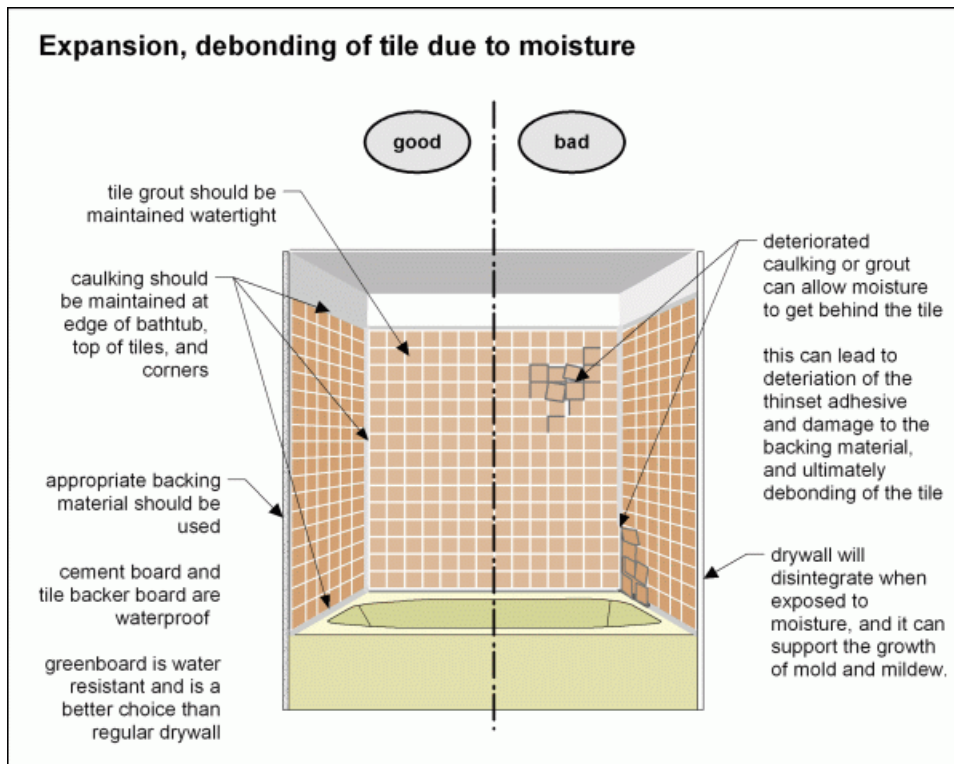
**109.** Grout loose, missing or deteriorated

### 40. Condition: • [Grout loose, missing or deteriorated](#)

Deteriorated grout at the hallway bathroom shower

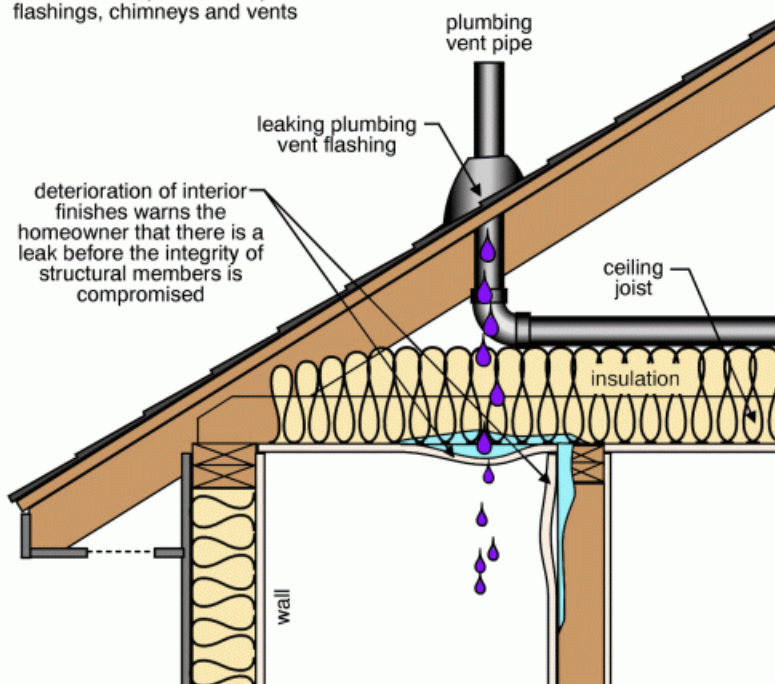
119. Water damage

#### 42. Condition: • [Water damage](#)

Water damage at the first floor HVAC closet. No moisture present at the time of the inspection.

**Task:** Repair

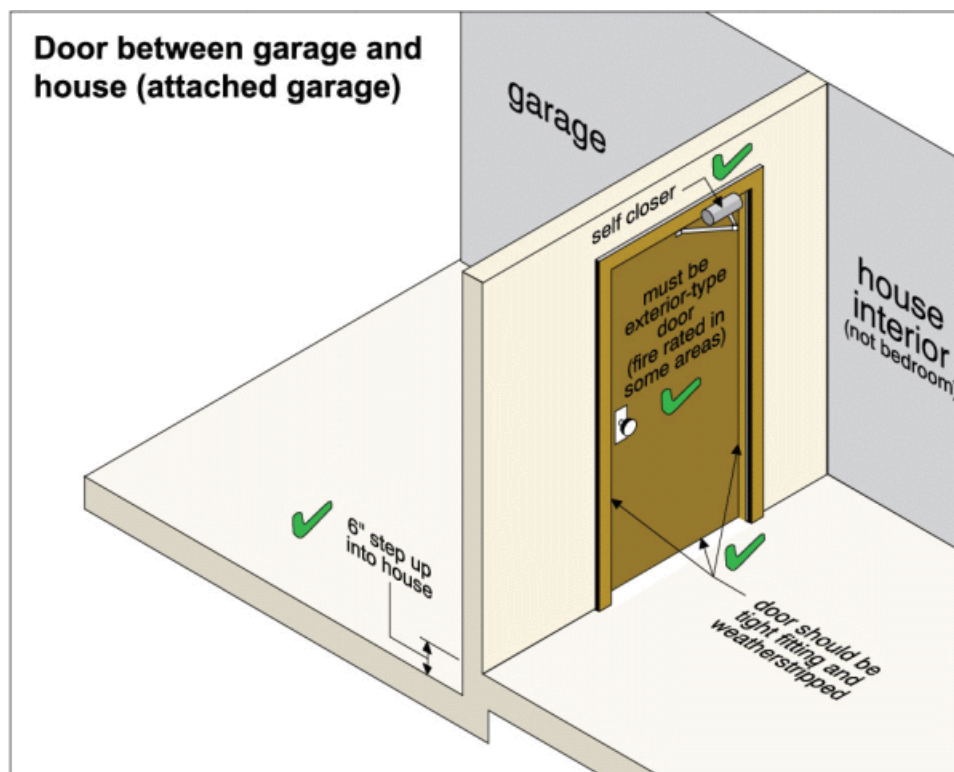
122. No self closer

43. Condition: • [No self closer](#)

**Implication(s):** Hazardous combustion products entering home

**Task:** Repair
