# LIGHTHOUSE ENGINEERING, L.L.C.

Date: Friday, July 21, 2023

RE: Engineering Evaluation – Distress Inventory Report and Structural Performance  
Express Limited Major Structural Defect Warranty

Homeowner - Nicole Neely (Current Homeowner)  
Subject Address: 2121 Pecan Leaf, New Braunfels, TX 78130  
Date of Closing -

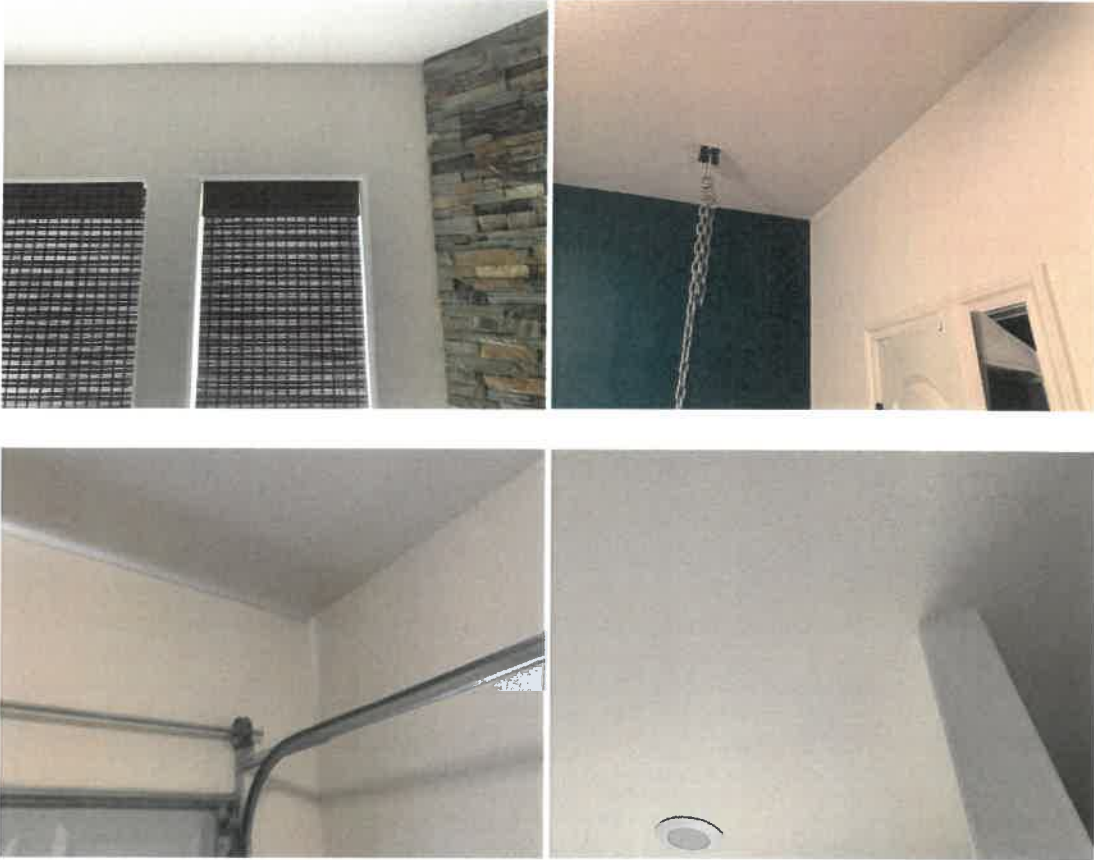
Pictures I3 - I6: General interior pictures.

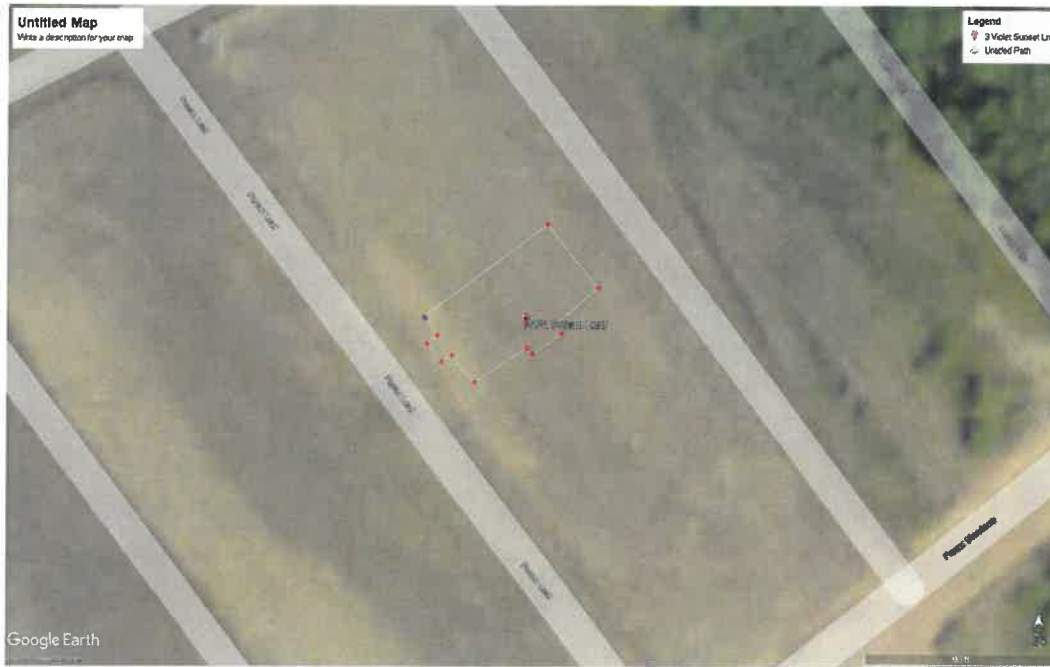
1. There were no obvious negative contributing factors to the lot development prior to construction. This photo was taken May, 2008 prior to the development of the lot.
2. The subject Home is constructed on the Sunev Loam Soil group. These soil properties were reviewed pertinent to the subject property. (WebSoilSurvey)

Picture 1: Pre lot development prior to construction.
